# Asset Assessment Report

Ex-Mission Bay Bowling Club

9 Tagalad Road

SAP ID: 10468-B025

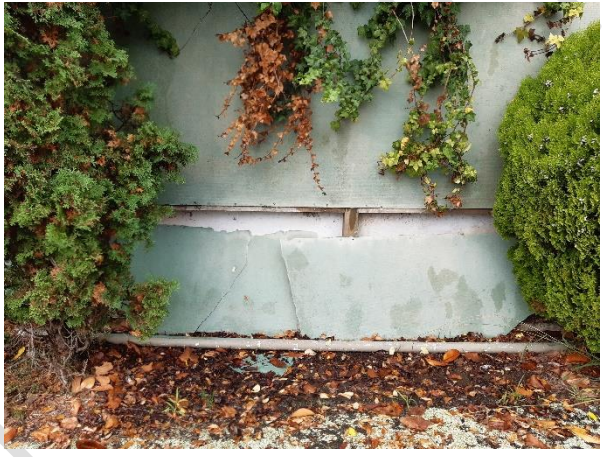
14	Remediate fibrolite fence. Maintenance required.

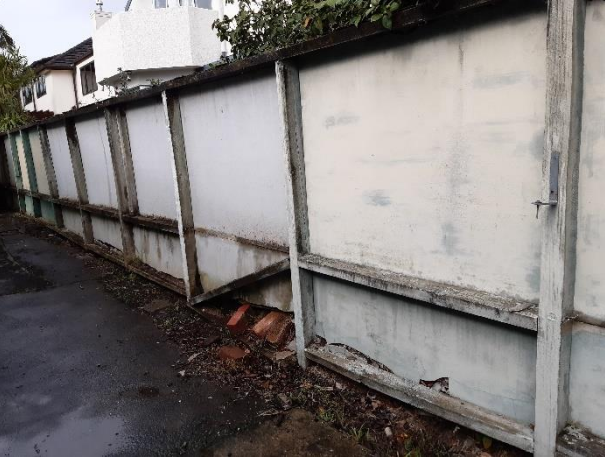
15	Damaged fencing to be rectified.

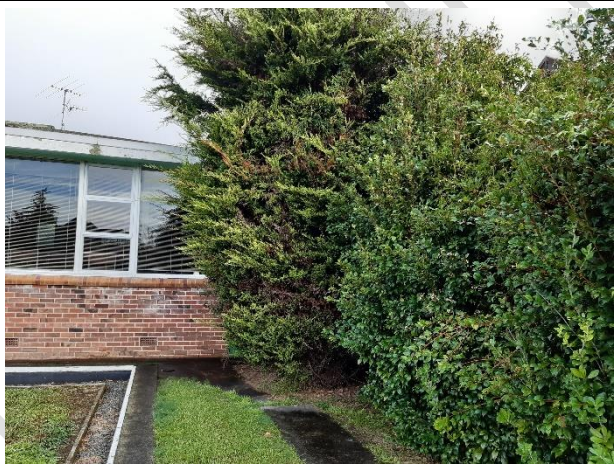
26	Trimming and general maintenance required.

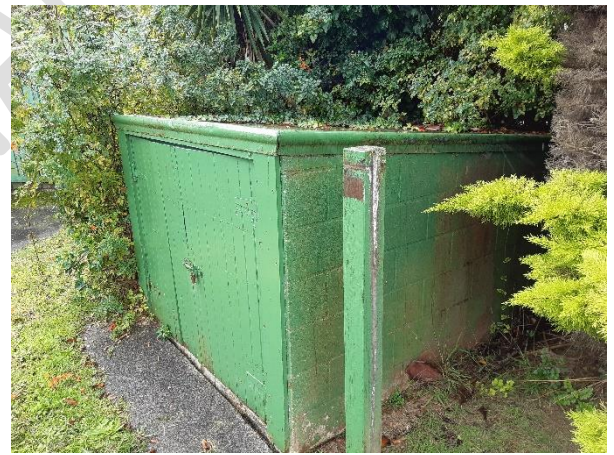
27	General condition of a store. Cleaning and regular maintenance required. Repainting and antirust treatment recommended. If the users' requirement has changed, we suggest demolishing the structure and cart away.

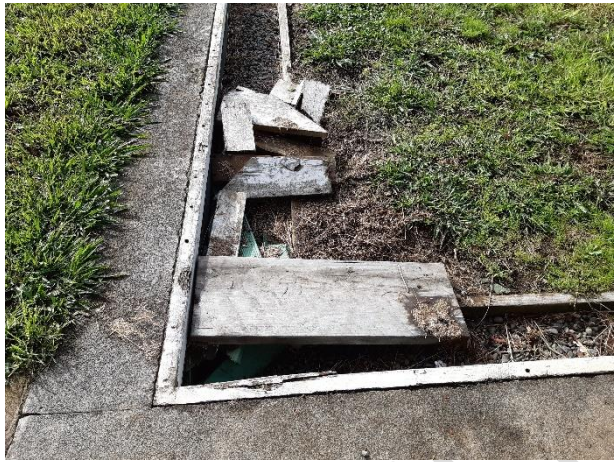
29	Debris and loose items to be removed.

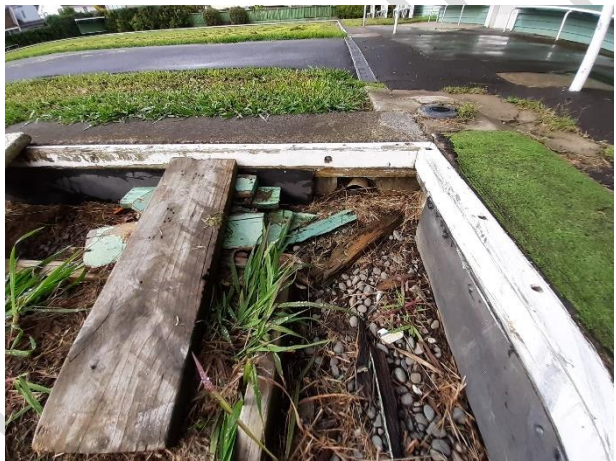
30	Debris and loose items to be removed.

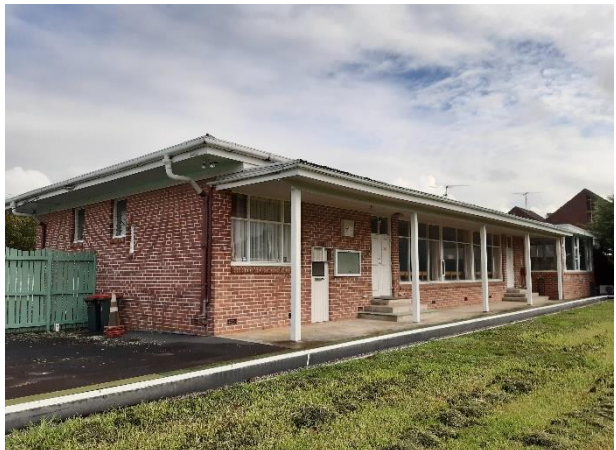
1	Front view of the bowling pavilion. ACM gutters and soffits have been found in the building. Monitoring of the condition and activities around to be managed.

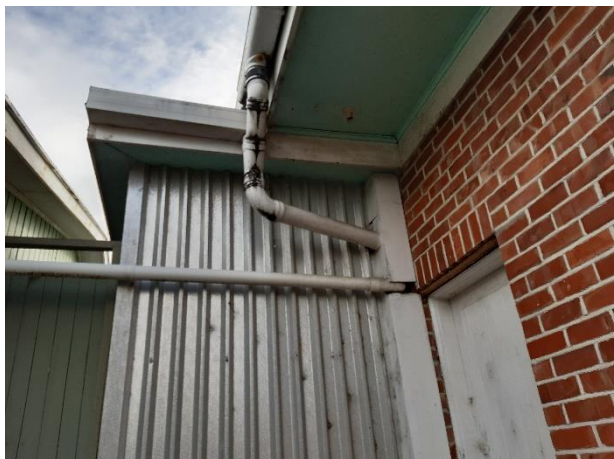
5	<p>To check and clear gutters and downpipes.</p>

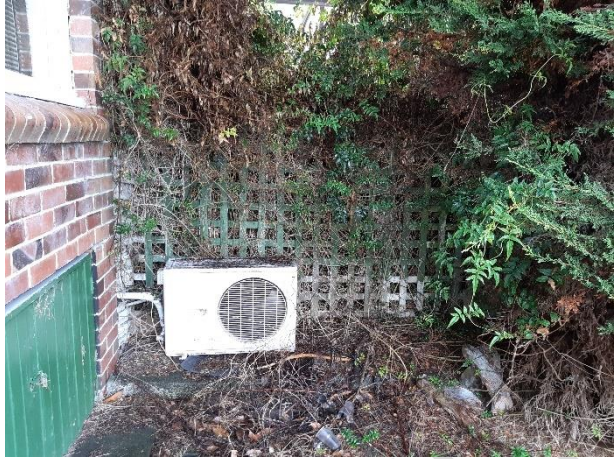
6	Clear and trim vegetation and trees. Servicing of air conditioning outdoor units required.

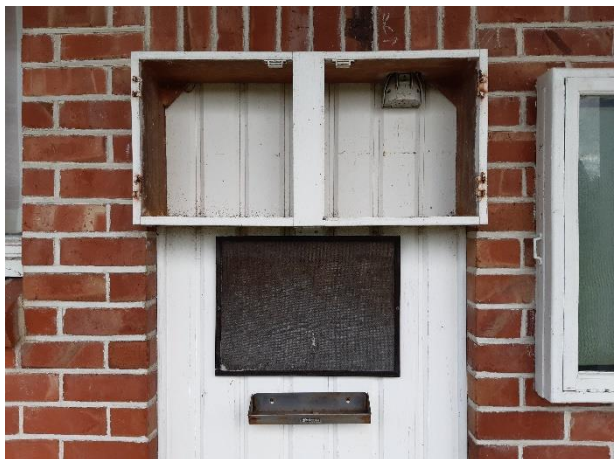
9	Remove casing no longer in use.

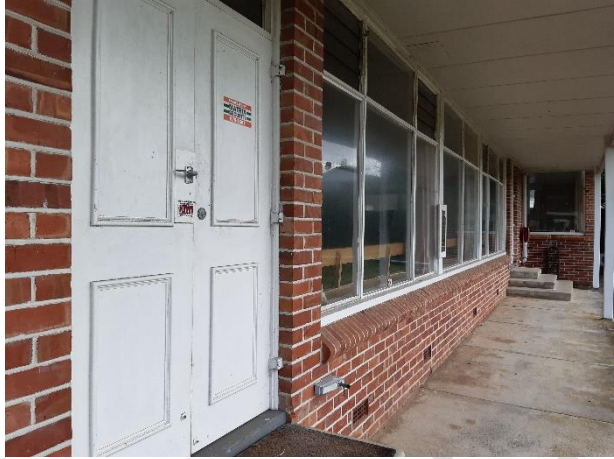
10	Ease and adjust all windows and doors and replace faulty ironmongery.

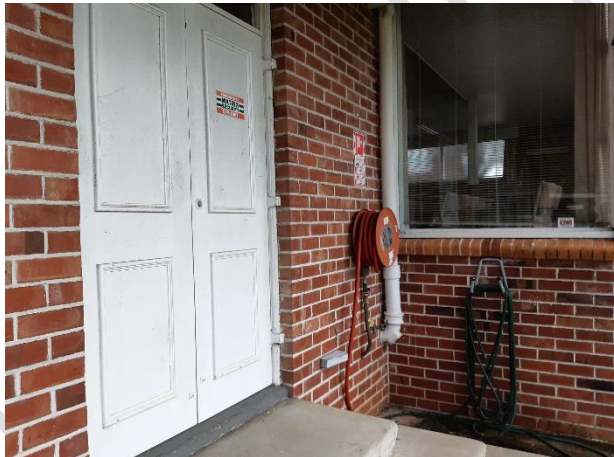
11	Ease and adjust all windows and doors and replace faulty ironmongery.

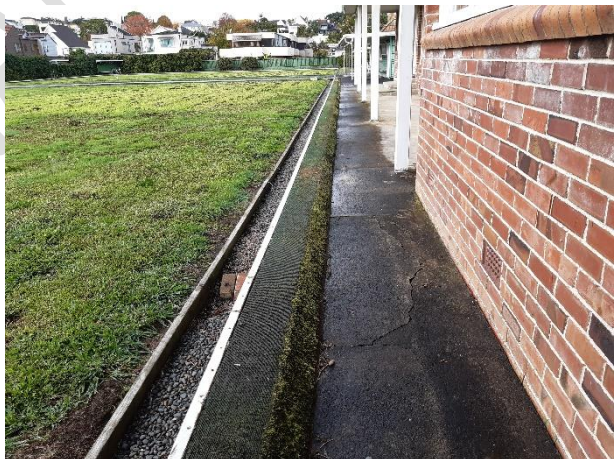
12	Perimeter slab cracks to be remediated.

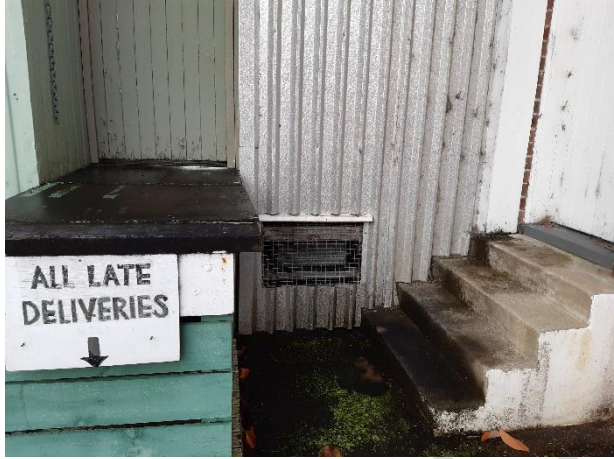
14	Remove signage. General cleaning and maintenance required. Chiller room condenser to be serviced regularly (no access gained to the room).

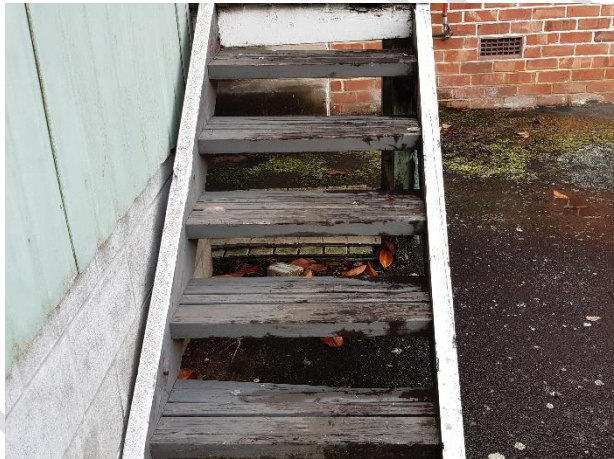
15	Check and replace all damaged steps.

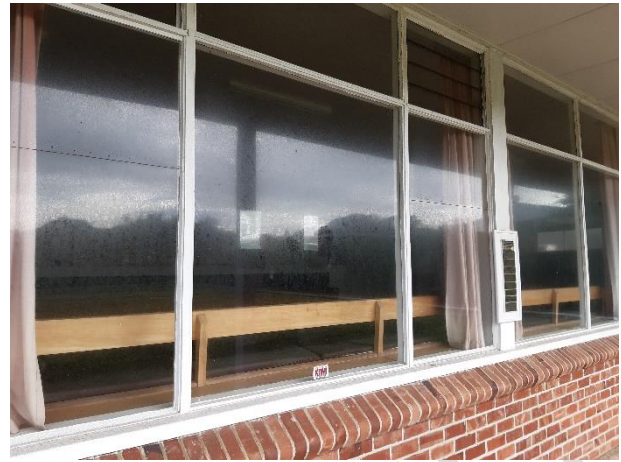
18	Window cleaning required.

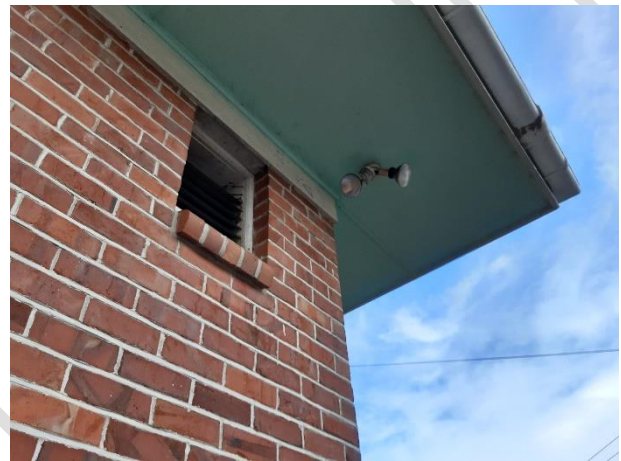
19	To replace missing louvre glass panes

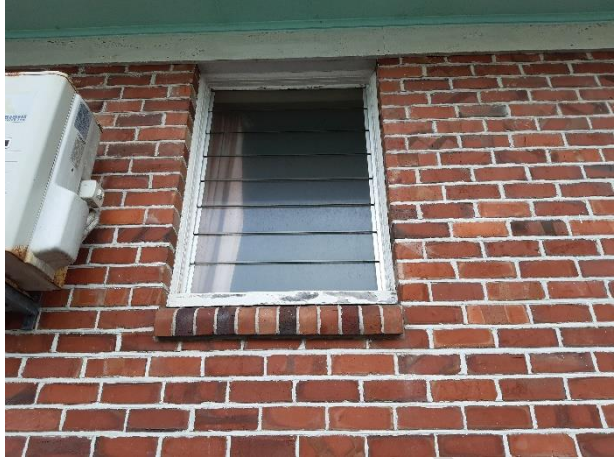
22	General window cleaning required.

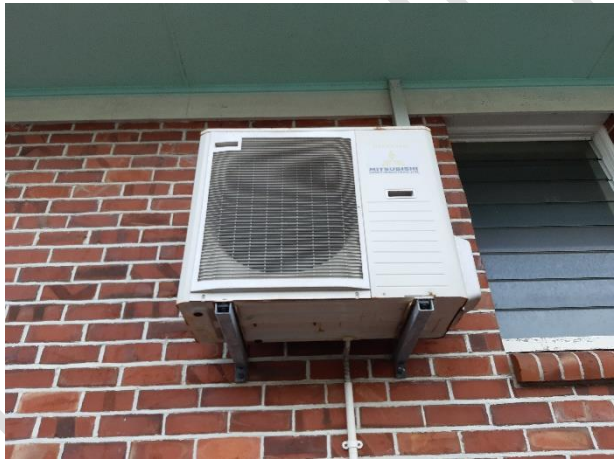
23	Air conditioning unit to be serviced regularly.

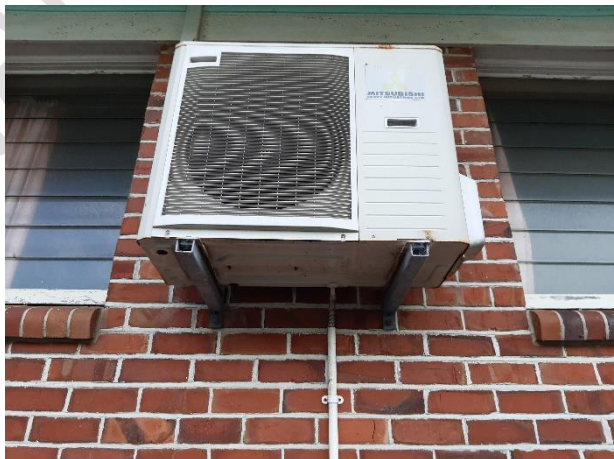
24	Air conditioning unit to be serviced regularly.

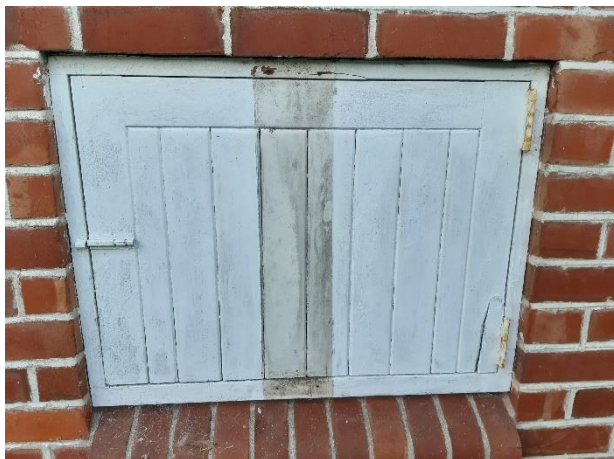
25	Ease and adjust access door to the sub-floor.

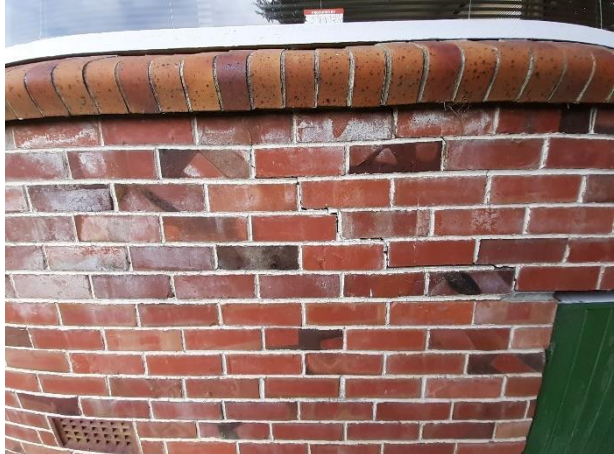
**The Main Pavilion** - Step cracking found on the North East corner to be remediated. Ease and adjust all windows and doors, and faulty ironmongery to be replaced. Encapsulation of asbestos gutters and soffits (make good prior). Interiors appear in moderate and serviceable condition. The bar and facilities could be demolished to make way for more space if required. Fire protection systems and safety to be further assessed if the new use exceeds 100 users. The Building Warrant of Fitness (BWOFF) and current fire protection systems should be renewed and checked.

26	Grout and repoint step cracks on brick wall.

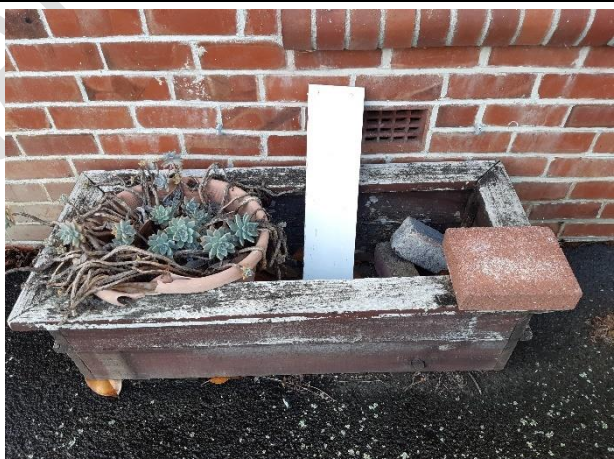
28	To remove planter box not in use.

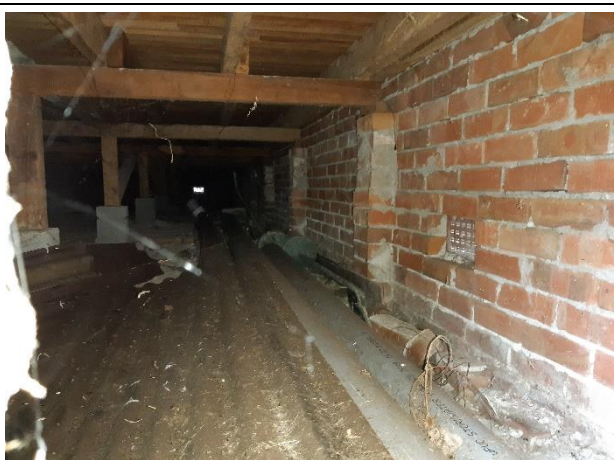
29	Sub-floor condition. No access gained.

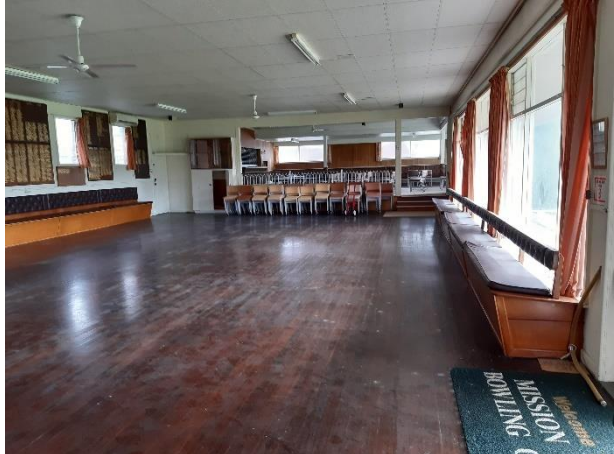
30	Main Hall appears to be in fair condition. General cleaning is recommended.

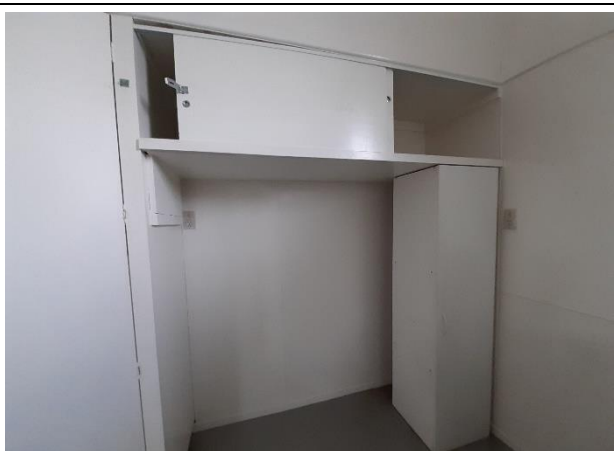
33	Kitchen cabinet in fair condition.

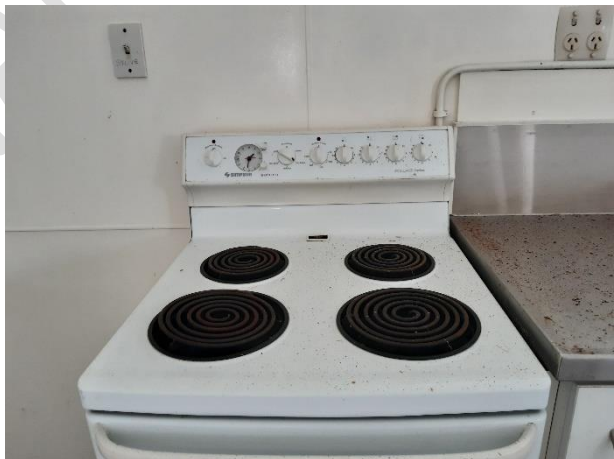
36	Cooker hob and oven to be checked prior to use.

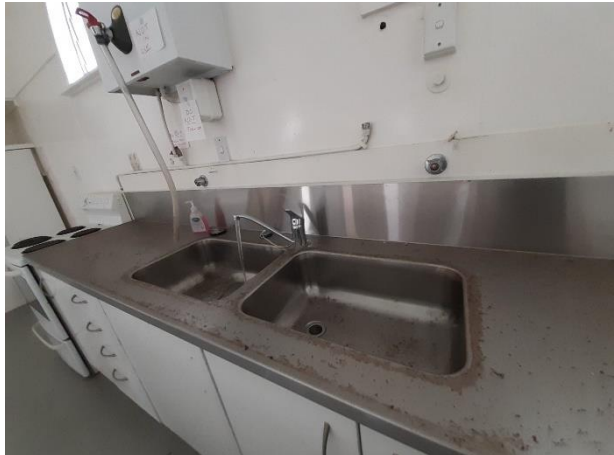
37	Kitchen sink in fair condition.

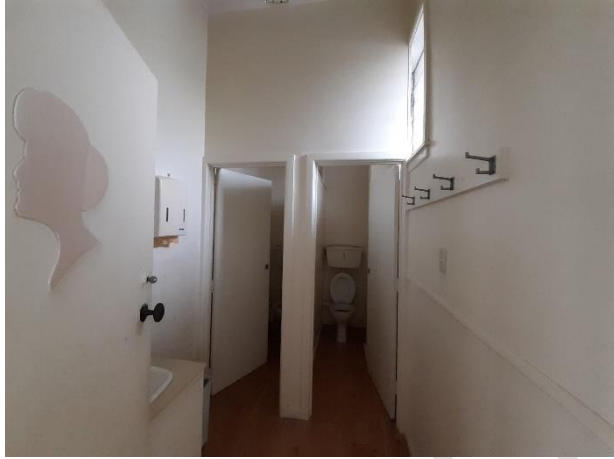
38	Female toilet in fair condition.

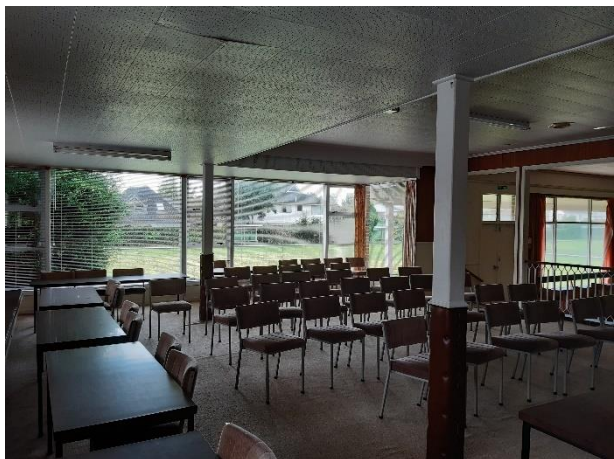
41	Lounge. Isolated ceiling tile needs remediation.

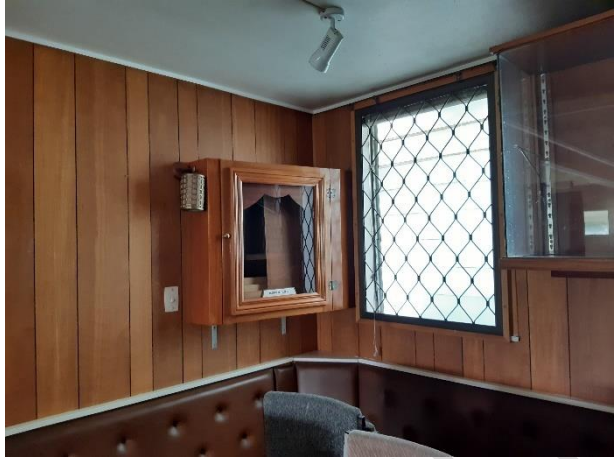
46	Lounge seating area in good condition.

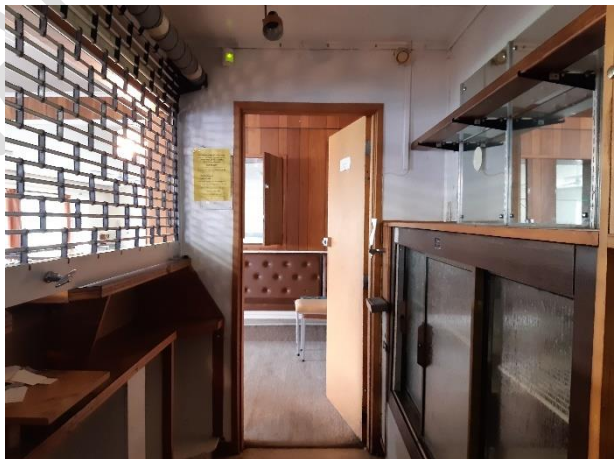
48	Bar counter and fridge.

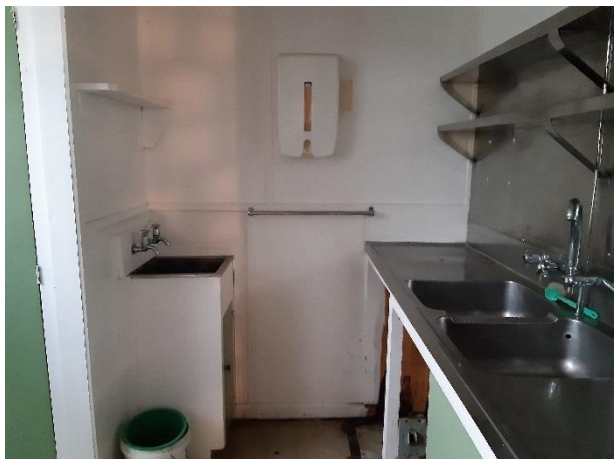
49	Kitchen in moderate condition. Kitchen cabinet dated.

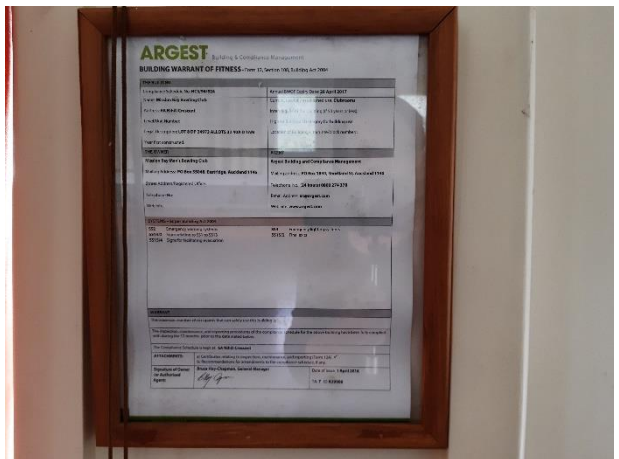
57	BWOFF has not been renewed.

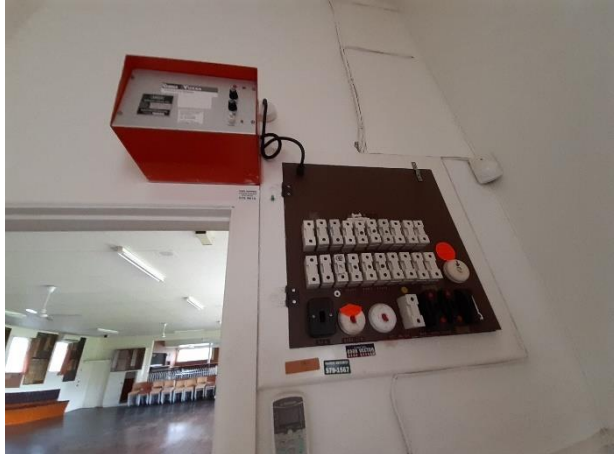
66	Electrical mains and switchboard located in the office.

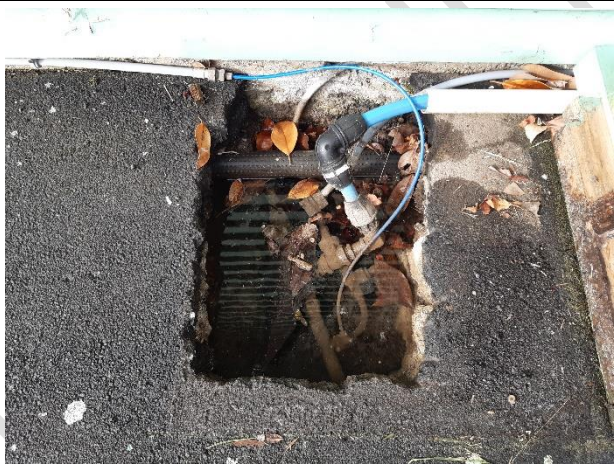
67	Water mains and valve. Proper cover is recommended.

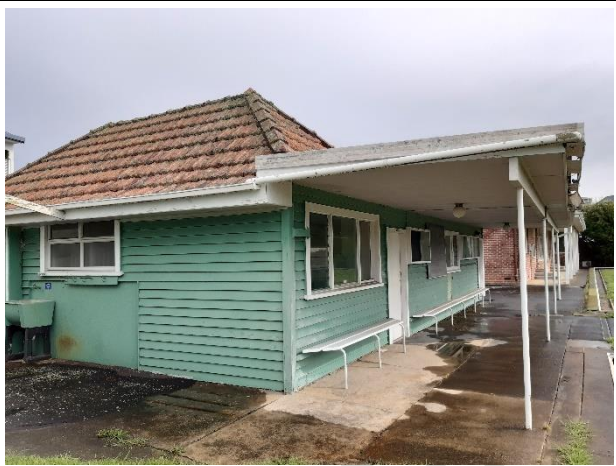
1	Exterior front view of the building. Gutters to be replaced.

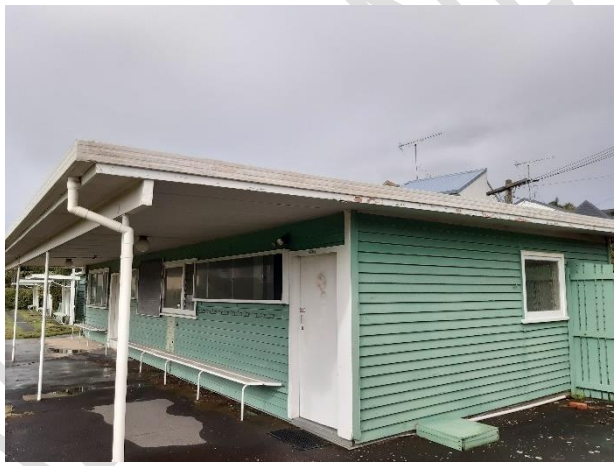
**The Toilets and Lockers Room Block** – In fair and serviceable condition. Cleaning and regular maintenance recommended. Some minor touch up work is required internally. The metal gutter has corroded and should be replaced. No access gained to the tool store on the rear left-hand side of the building.

2	Barge flashing showing signs of corrosion. Metal gutter 'end of life' - to be replaced as soon as possible.

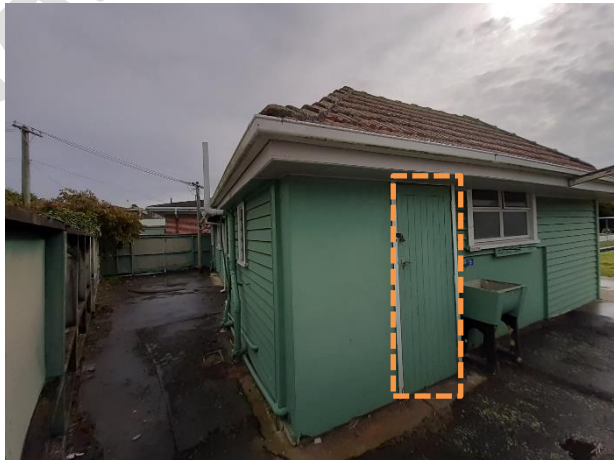
3	No access gained to the store.

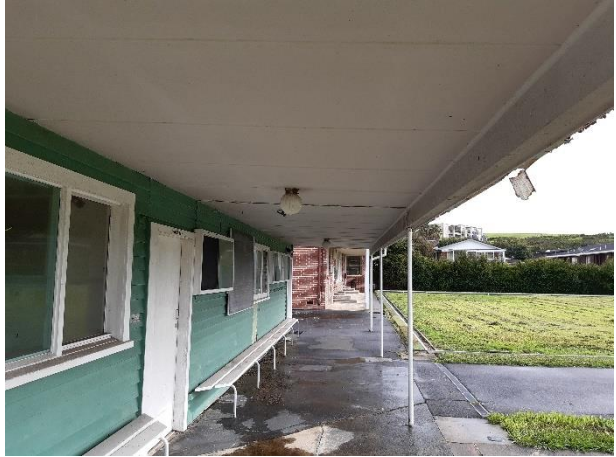
4	Verandah canopy soffit – presumed to be asbestos containing materials. To monitor condition and manage activities in the area.

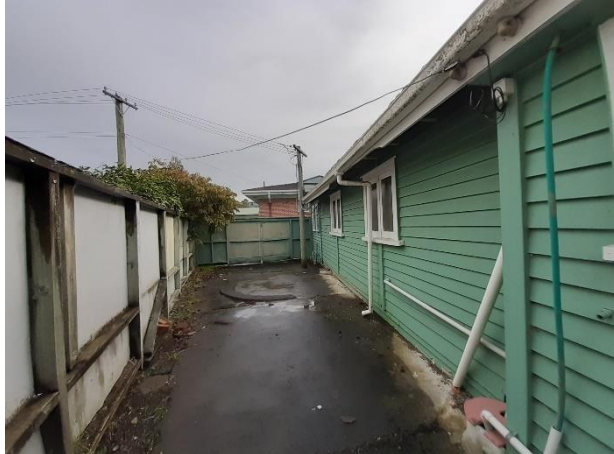
5	Rear of the Toilet and Locker Room Block. To monitor the condition of fibrolite fencing – check for ACM.

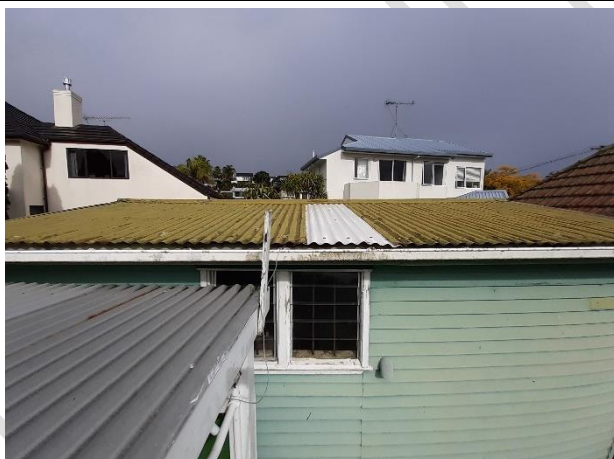
6	Long run metal roof showing signs of corrosion. Anti-rust treatment required. We recommend replacing the roof in 10-15 years.

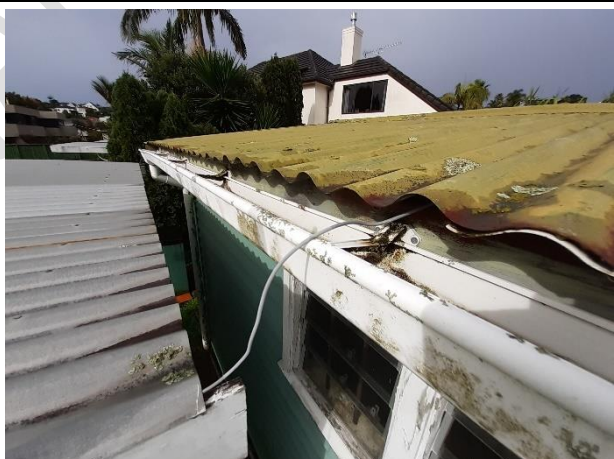
7	Long run metal roof showing signs of corrosion. Anti-rust treatment required. We recommend replacing the roof in 10-15 years.

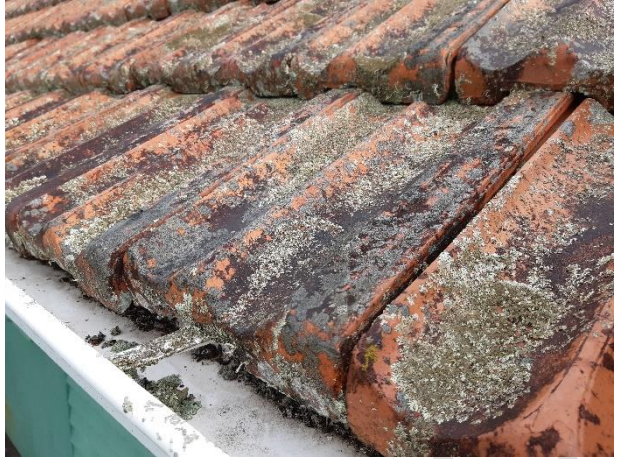
9	General cleaning of the clay roof and monitoring of the condition.

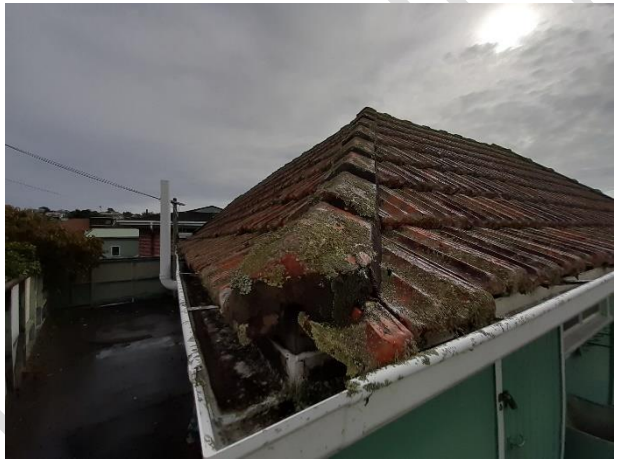
10	General roof cleaning required. Damaged end ridge tile to be replaced.

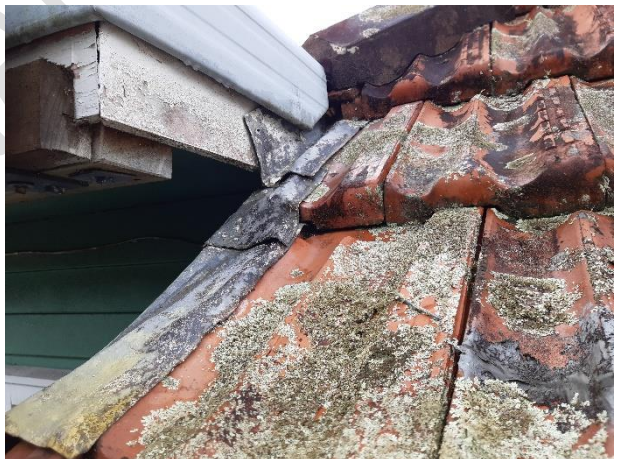
11	General cleaning of the clay roof and monitoring of the condition for flashing required.

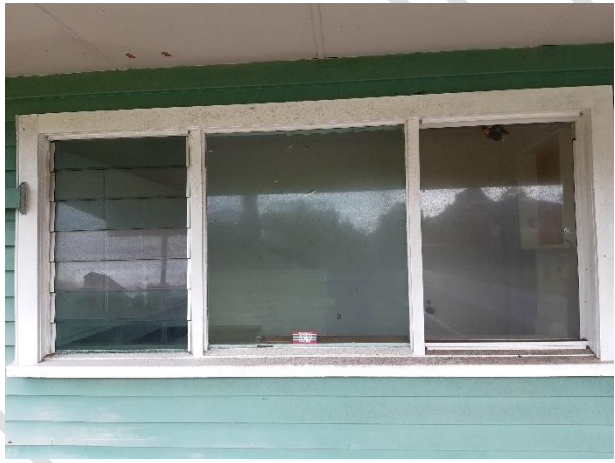
18	General cleaning recommended for all windows.

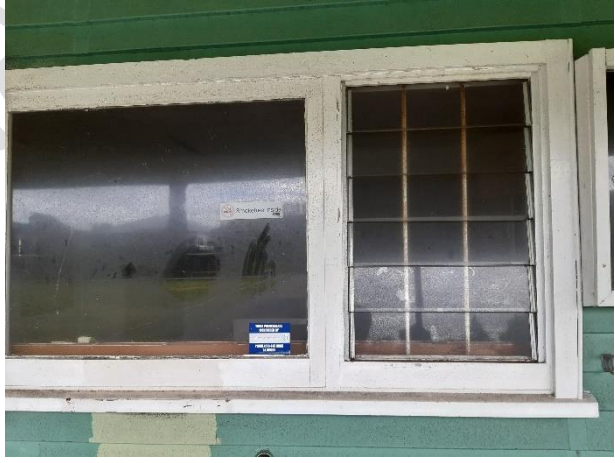
19	General cleaning recommended for all windows.

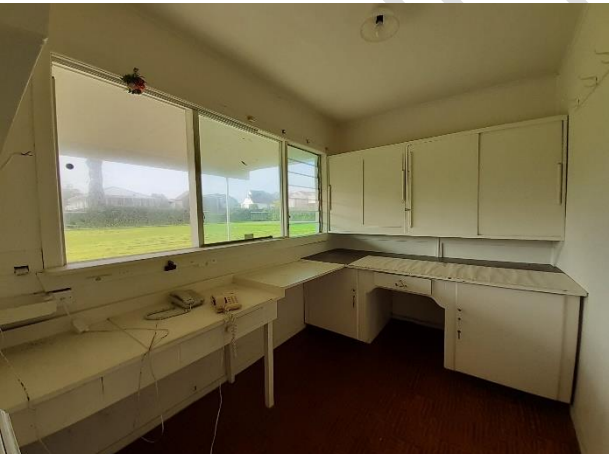
22	Office in fair and serviceable condition. All windows and doors to be eased and adjusted.

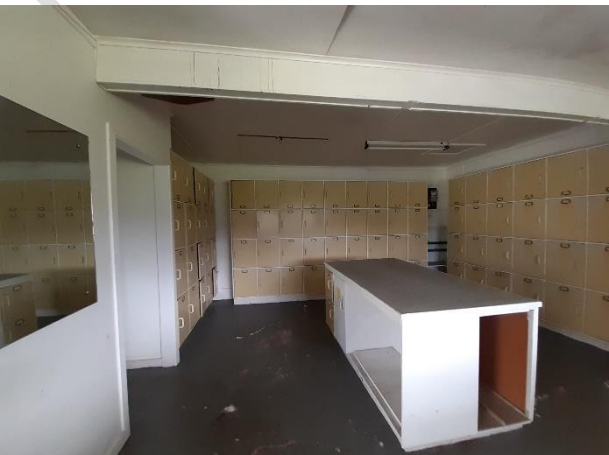
23	Male locker room. To securely fasten the ceiling boards.

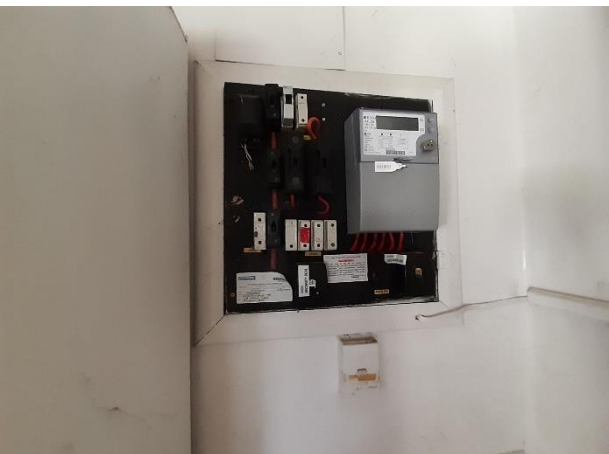
24	Asbestos 'Zelemite' electrical board. Warning sticker recommended. Regular monitoring of the condition and manage activities.

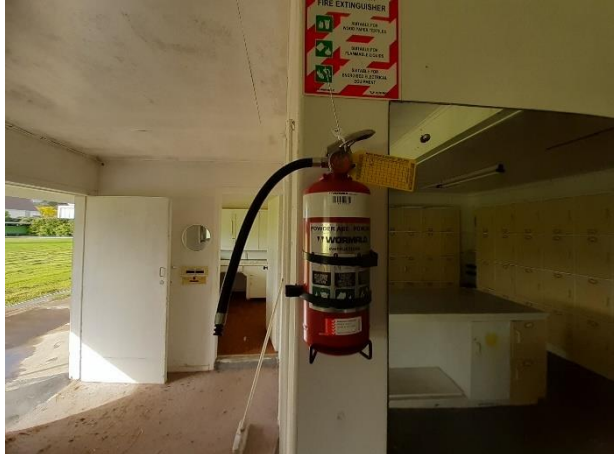
25	Service of fire extinguisher required.

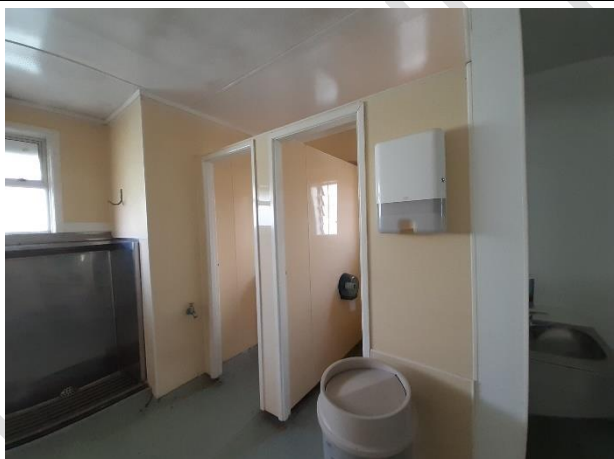
26	Male toilets and urinal in fair and serviceable condition. Urinal is dated and we recommend to replace with new urinal bowls upon the end of service life.

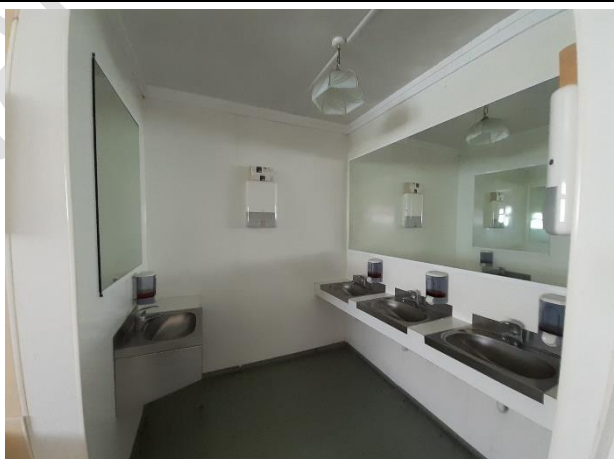
27	Male toilet – wash basins area in fair and serviceable condition.

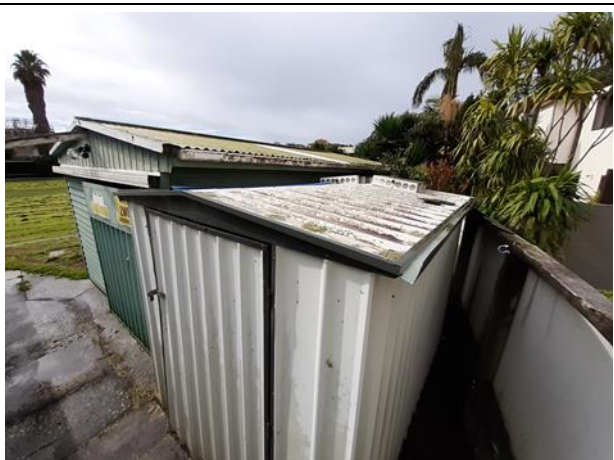
11	<p>Roof condition. Cleaning and general maintenance required.</p>

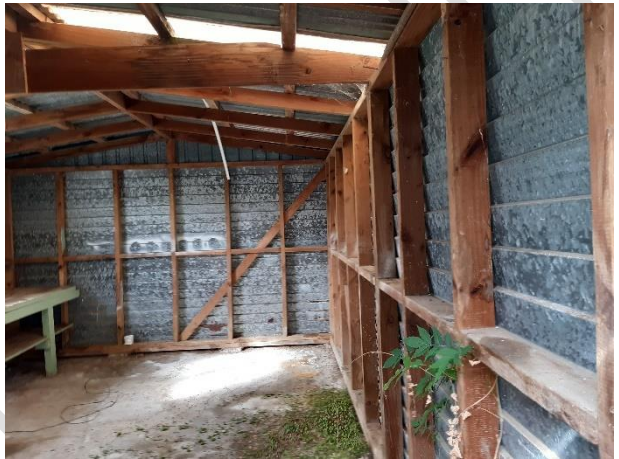
13	Clear vegetation growth.

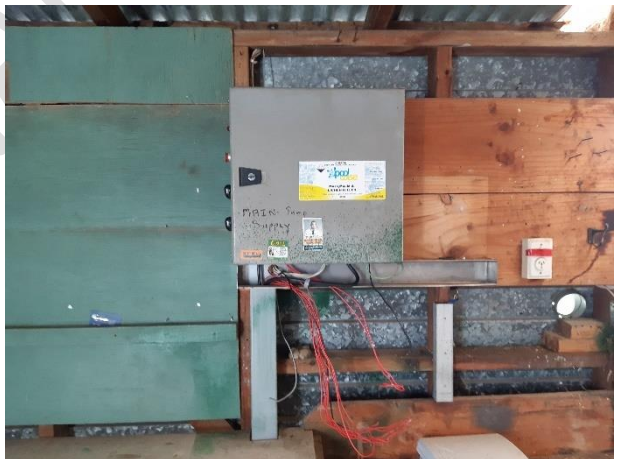
14	Recommend Registered Electrician to check electrical circuitry for safety after prolonged period of inactivity.

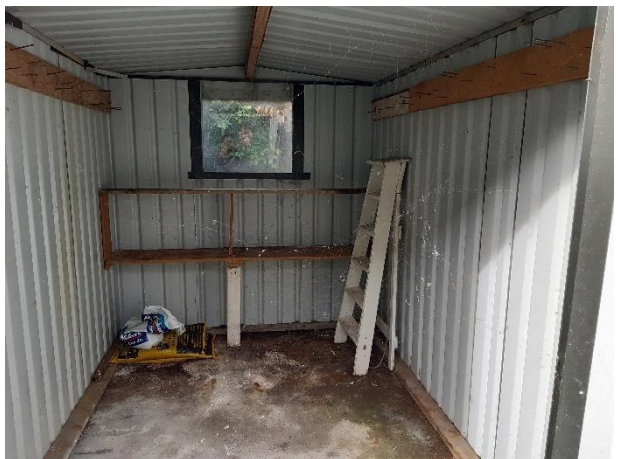
15	Storage shed appears to be in fair condition. General cleaning recommended prior to occupation.

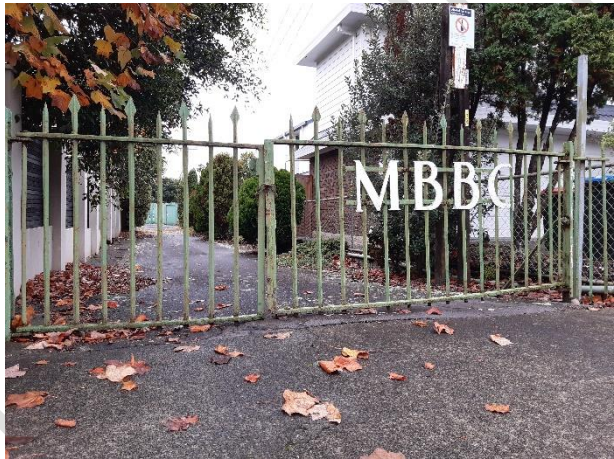
2	<p>Nihill Crescent entrance.</p> <p>Suggest to dismantle the fence/gate (proposed use to be confirmed) instead of incurring maintenance costs.</p>

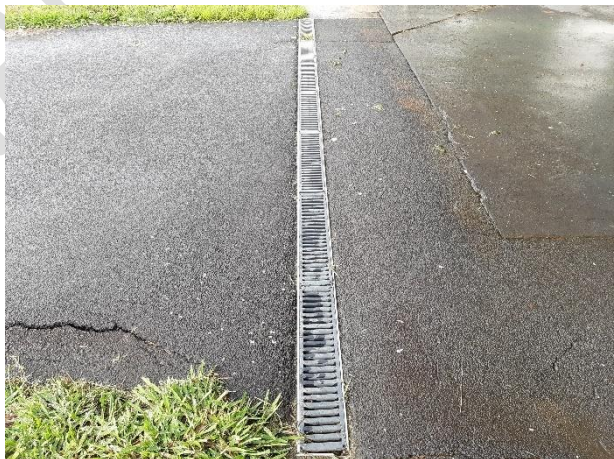
3	<p>Drain cover in good condition.</p>

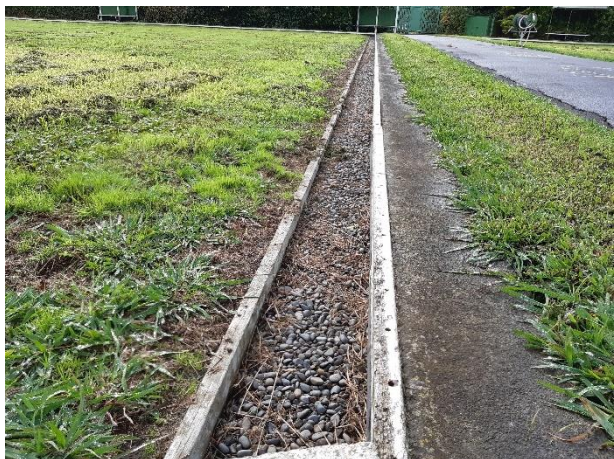
4	<p>General view of the bowling green.</p> <p>General maintenance, irrigation, mowing and clearing of grass required.</p>

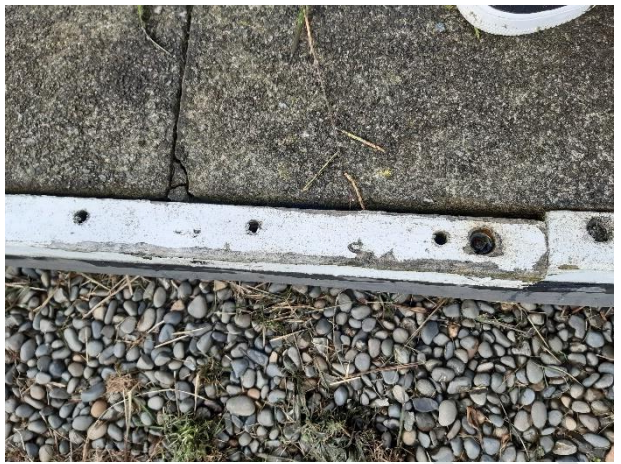
5	Remediate any loose timber fasteners for the bowling green.
