Mission Bay Safety Improvements

We have noticed a number of issues associated with the safety improvements at Mission Bay, and would like to bring these to your attention.

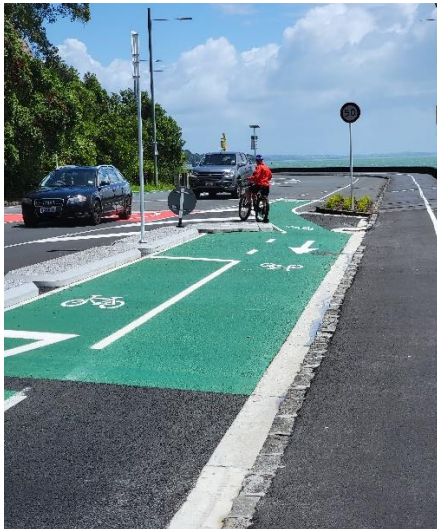
1. The western end cycle lane transition is confusing.

- a. The west-bound lane of the 2 way cycleway ends and it is not obvious where west-bound cyclists should go. In reality, they can choose to continue riding on the shared path, or cross the road to ride on the road, but the choices are not obvious.
- b. The problem with the shared path option is that nothing indicates that this is an option; there is no arrow on the cycle lane pointing towards the shared path, no cycle symbol on the shared path at that point (there is further west, but not visible from this point, and no signage).

- c. Crossing the road to continue cycling with the traffic is difficult. The west-bound cycle lane simply ends with a kerb across the end of the lane. To get onto the road, the cyclist must ride the wrong way through the gap in the kerb, and then wait for a gap in the traffic.

- d. It is surprising that the point at which cyclists will need to cross the road is just outside the 50km/h zone, rather than within the 30km/h zone. This is a higher risk point so deserves greater protection.

Solution: We think that this can be easily fixed with improved markings on the new and old cycle lanes, and possibly signage. This would include arrows on the west-bound cycle lane showing the two options (road or shared path) and an arrow and cycle symbol on the shared path where cyclists are expected to join.

Solution: We think that a better transition for west-bound cyclists could be designed. Perhaps the existing kerb that ends the lane could be removed, rumble strips or similar could be installed to make cyclists recognise that they need to slow or stop before crossing the road, and a clearly designated waiting area painted on the road.

Solution: We recognise that moving the 30km/h zone is difficult from a regulatory perspective. Instead, perhaps removing one or two of the 'tim tam dividers' might allow for a marked waiting area at the end of the west-bound lane. This could help solve the problem in (c) above as well.

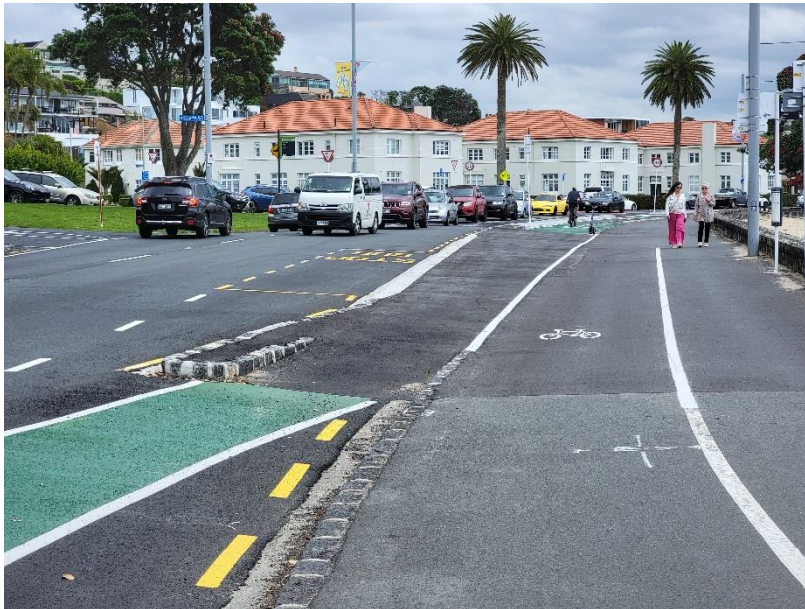
2. The eastern end cycle lane transition is confusing.

- a. There appears to be just a single lane exiting the 2-way cycle path and no way to enter it from the road.
- b. The cycle path appears to suddenly end before the bus stop, then resume as a single lane. There is a cycle path as part of the shared path throughout this section, but there is nothing to show that cyclists should move across to this area. Instead, the markings suggest that cyclists should cycle straight ahead right through the bus stop waiting area.

- The cycle path could be painted green throughout this section, with the two lanes moving across onto the shared path and leaving an unpainted island beside the bus stop. This would make it much clearer where bus passengers, pedestrians and cyclists are supposed to go.
- The single exit lane should be converted to a two-lane entry/exit.
- We also think that clearer markings to show the options of either moving onto the shared path or the road (as suggested for the western transition) would help.

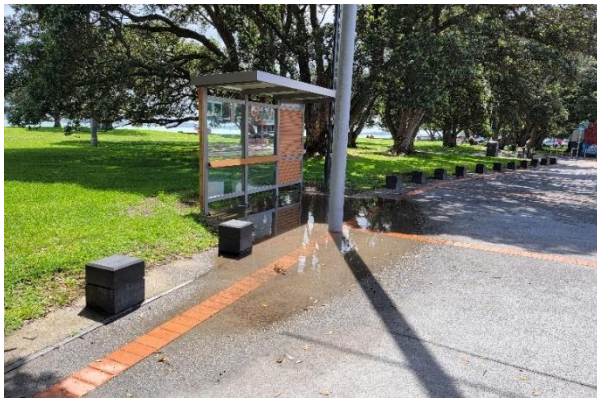
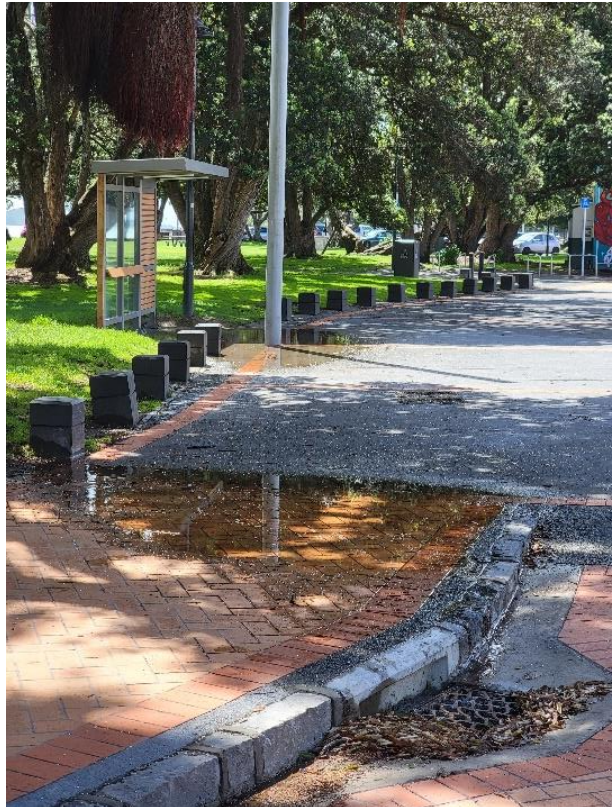
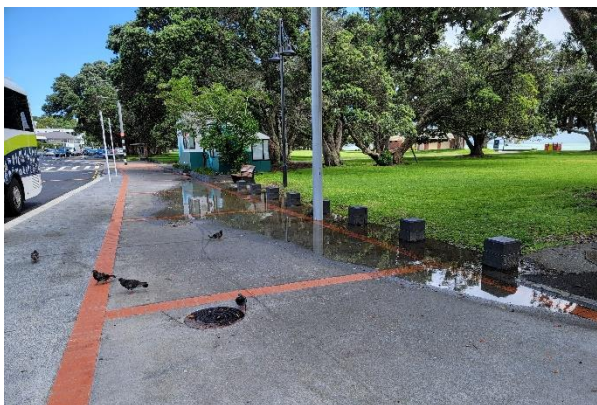
4. Problems with levels and drainage

- a. There are several areas where the paving slopes away from drainage, causing water to accumulate.
- b. There is also a drainage problem where the footpath connects to the path to the fountain.

Solution: These are construction errors and should be repaired by the contractor.
