# Asset Assessment Report

Ex-Mission Bay Bowling Club

9 Tagalad Road

SAP ID: 10468-B025

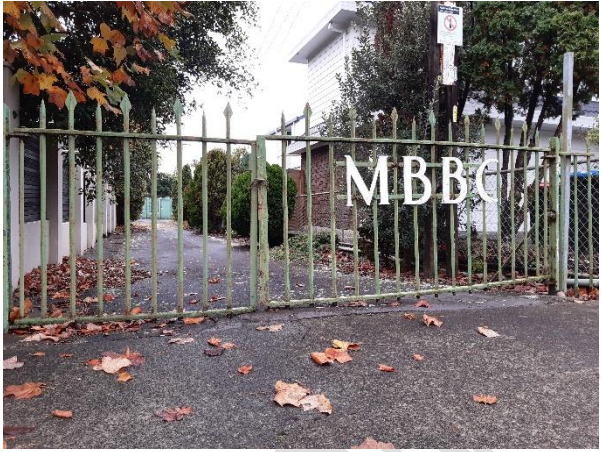
1	Main gate at Nihill Crescent entrance. Ease and adjust. Anti-rust treatment and repainting recommended.

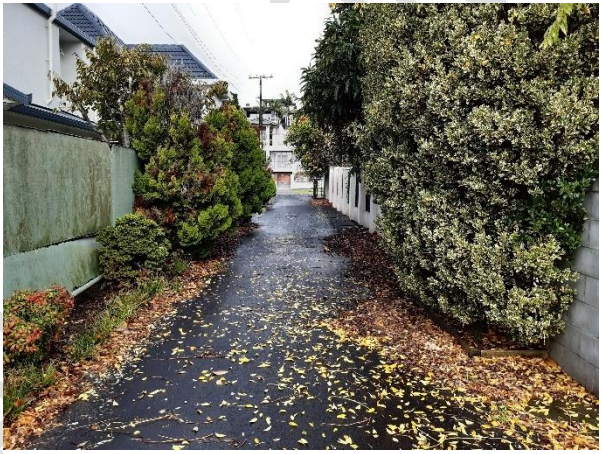
2	Regular general maintenance and cleaning of the driveway and the trees and vegetation required.

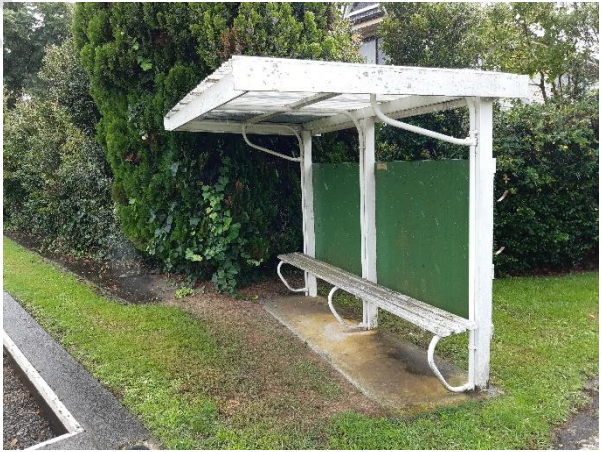
3	General condition of all typical free-standing shelters. Cleaning and regular maintenance required. Repainting and anti-rust treatment recommended. If the users requirement has changed, we suggest demolishing and cart away the sheds.

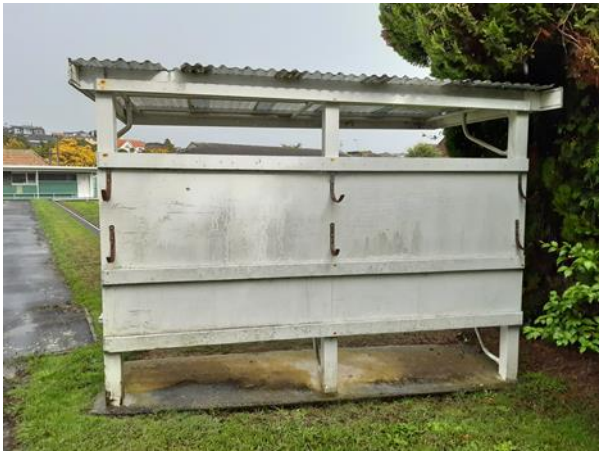
4	Shed – suggest removing brackets and make good wall surface. Depending on future use these shelters may not serve any further purpose – suggest demolishing and cart away and make good ground slab.

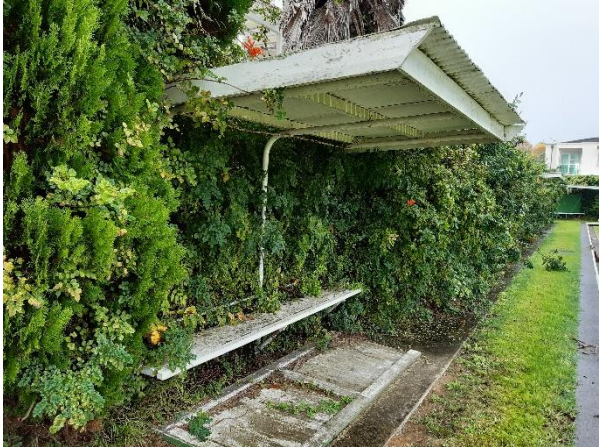
5	<p>General condition of typical shelters mounted on the wall. Cleaning and regular maintenance required. Repainting and anti-rust treatment recommended. If the users requirement has changed, we suggest demolishing and cart away the shelters.</p>

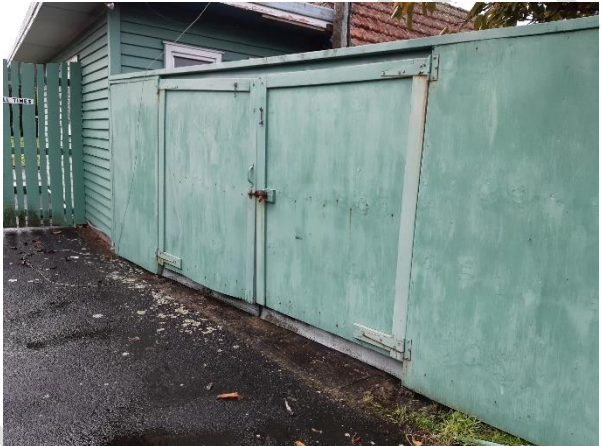
6	<p>Ease and adjust timber gate to the rear of the Toilet &amp; Locker Room block. Rusted and faulty ironmongery to be replaced. Regular painting.</p>

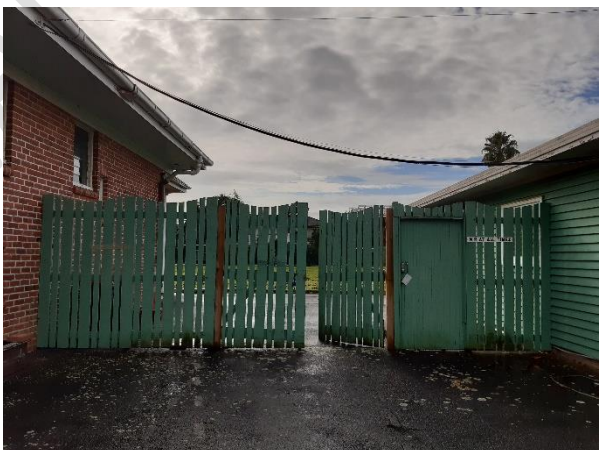
7	<p>Ease and adjust timber gate to the bowling green. Rust affected and faulty ironmongery to be replaced. Propose regular painting. To demolish the fence/date if this is no longer required by the new users.</p>

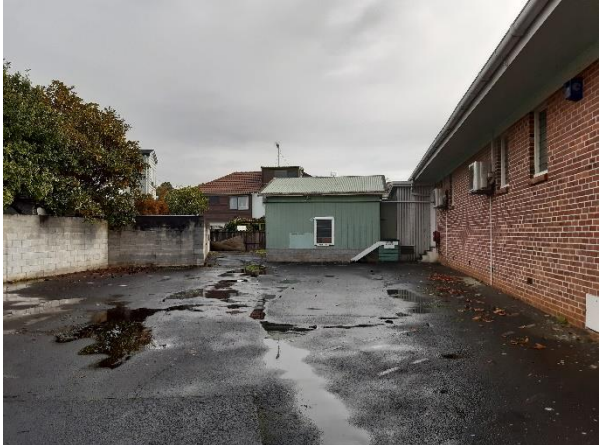
8	<p>Uneven driveway surface to be remediated.</p>

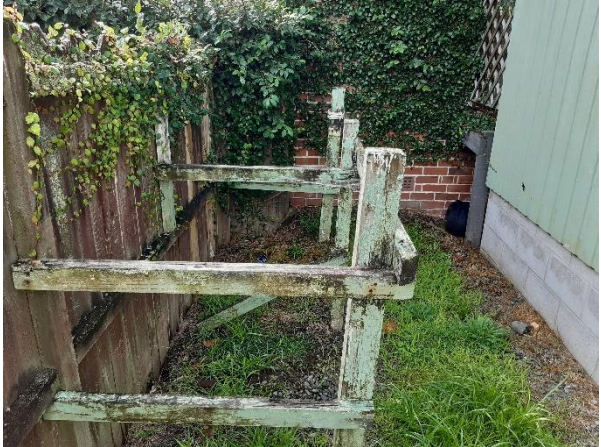
9	Check and remove timber structure. General ground maintenance required.

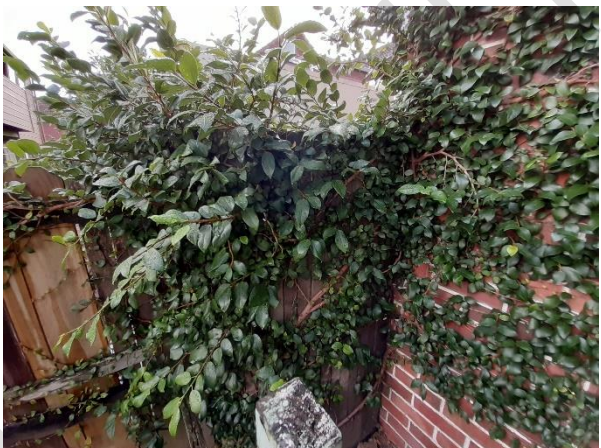
10	Trim trees and vegetation and general maintenance for the wall and fences recommended.

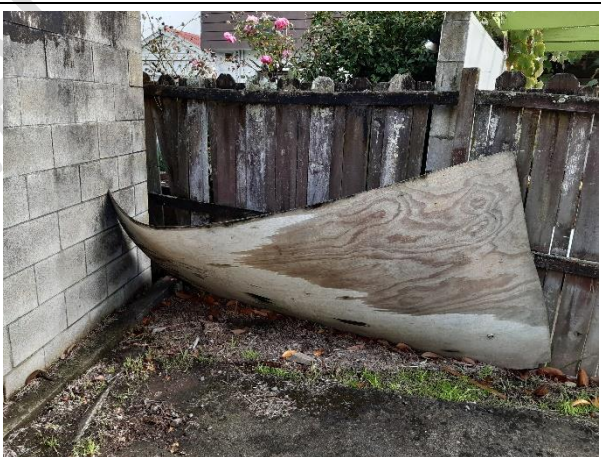
11	Cleaning and general maintenance for the timber fences recommended. Remove and cart away loose plywood sheet.

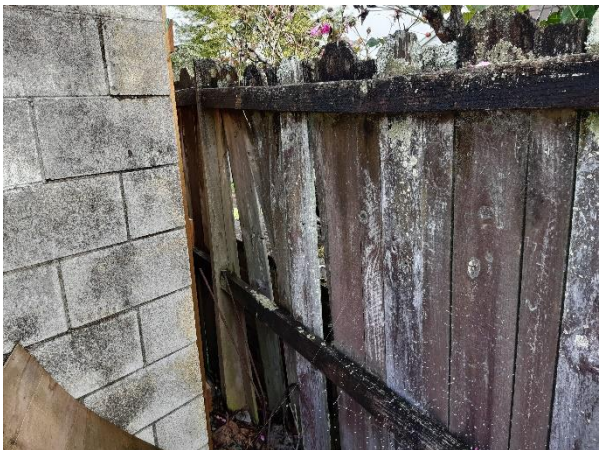
12	Cleaning and general maintenance for the timber fences recommended.

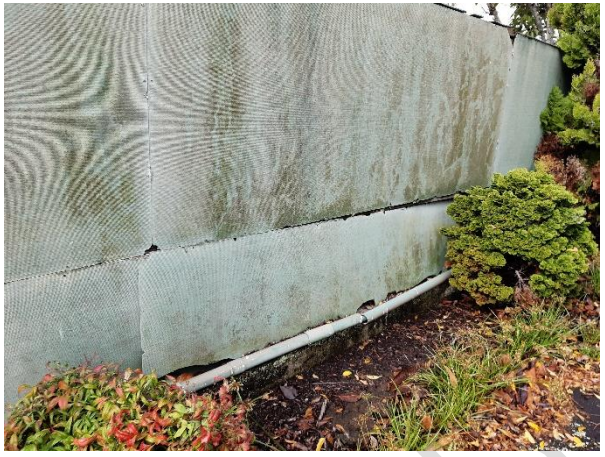
13	Remediate fibrolite fence. Repainting required.

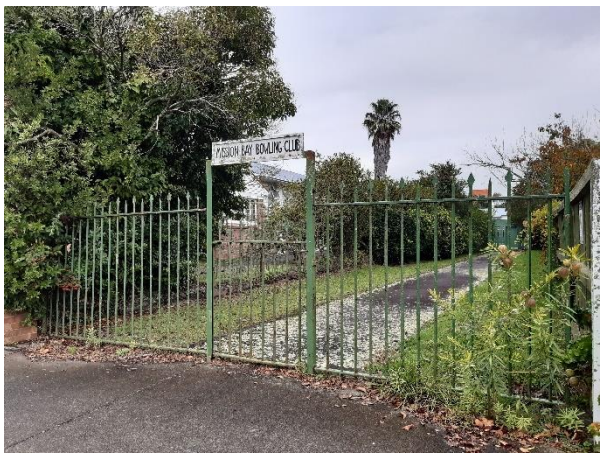
16	Repaint metal gate and/or replace the signage. If new users no longer require the gate, propose to remove to reduce maintenance cost.

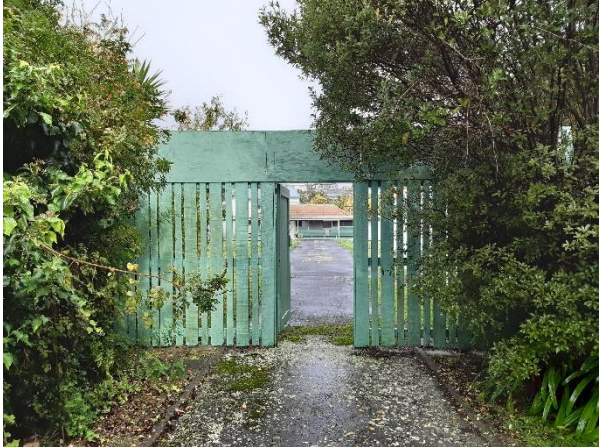
17	Gate to be removed and cart away as the users' requirement may have changed. Alternatively make good any damage and repaint.

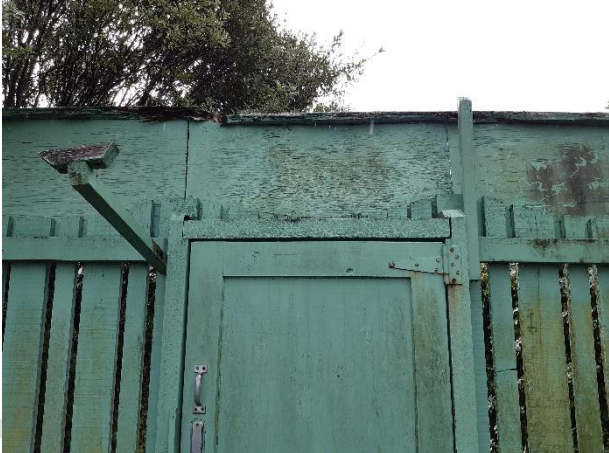
18	Repair and make good timber top plate. General cleaning required.

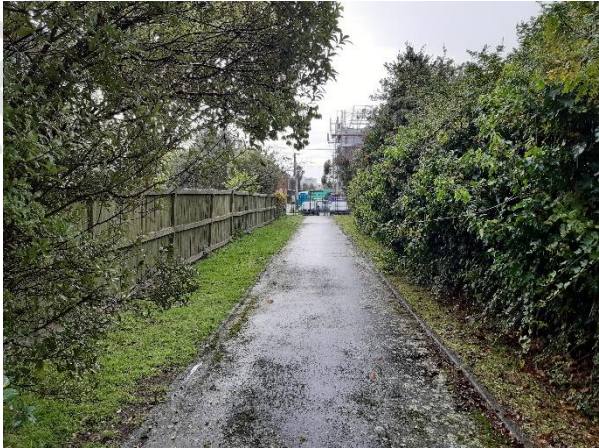
19	Walkway surface needs cleaning and regular general maintenance. Trim and maintain vegetation and trees around the property.

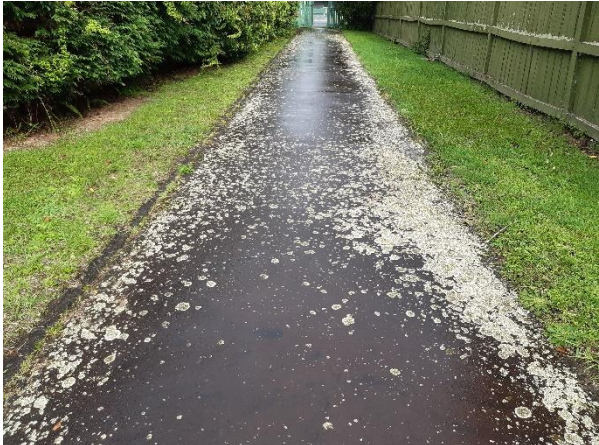
20	Walkway surface needs cleaning and regular general maintenance. Trim and maintain vegetation and trees around the property.

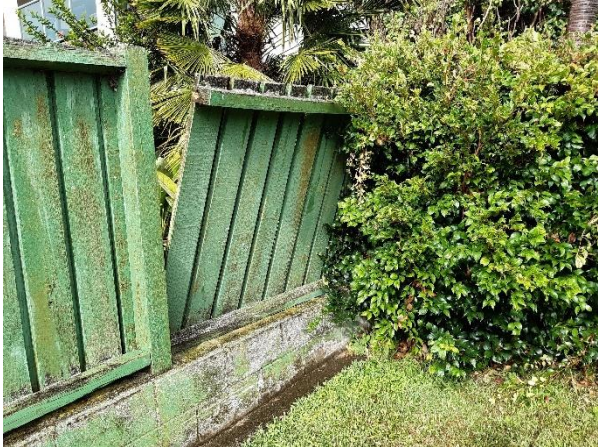
21	Damaged fence to be remediated.

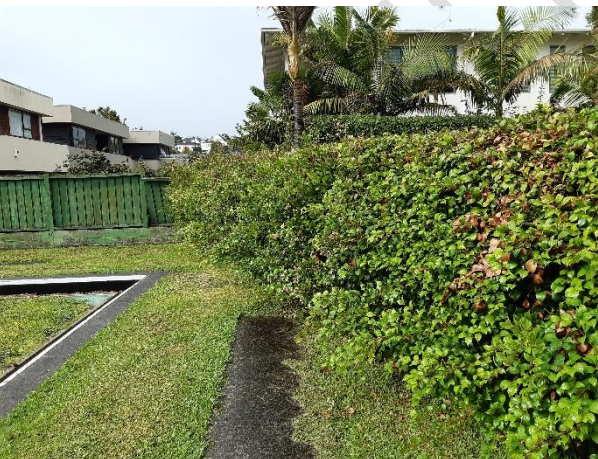
22	Trim and maintain vegetation and trees around the property.

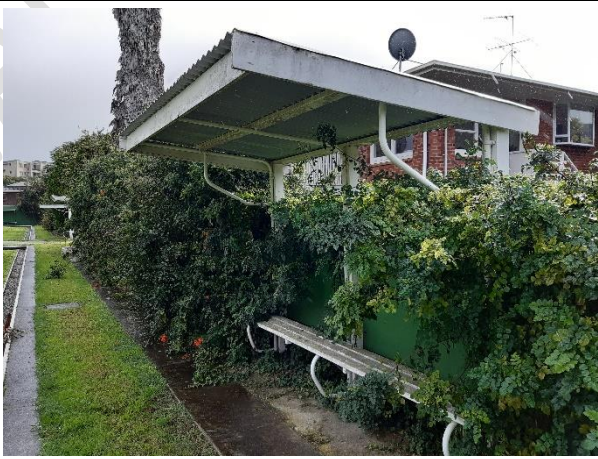
23	General condition of typical sheds mounted on the wall. Cleaning and regular maintenance required. Repainting and antirust treatment recommended. If the users' requirement has changed, we suggest demolishing and cart away the sheds.

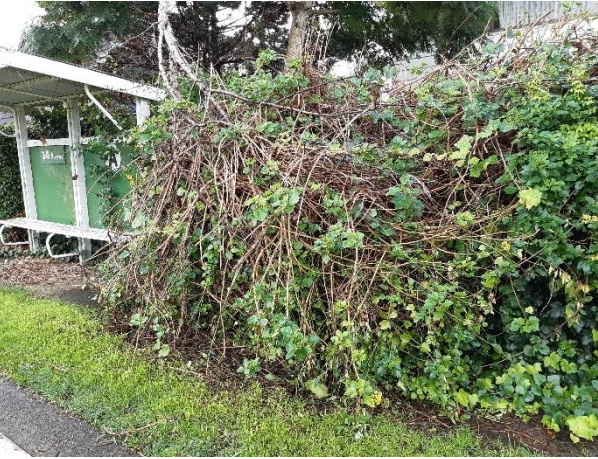
24	General maintenance required.

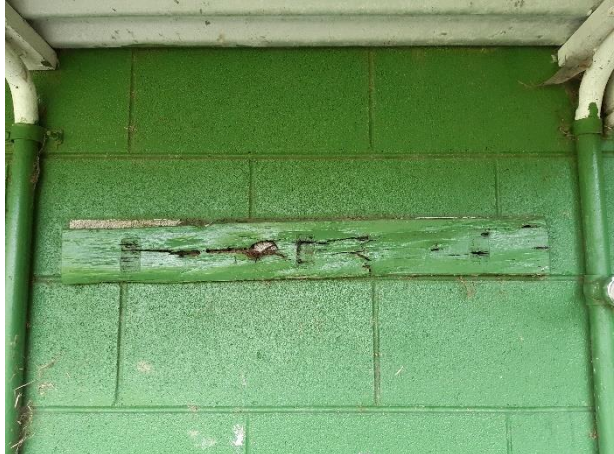
25	Minor fixes for typical sheds.

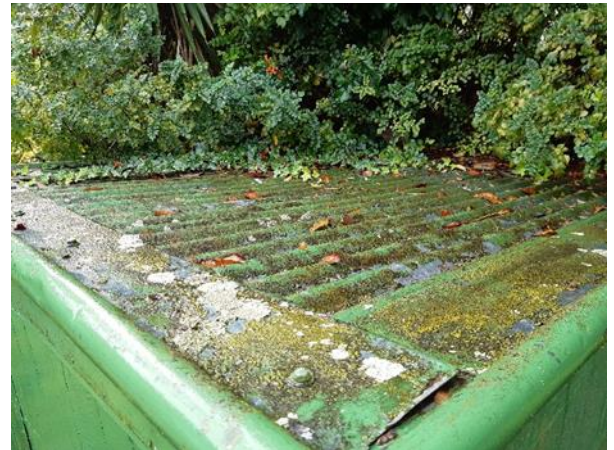
28	The roof condition of the store. General cleaning and maintenance required.

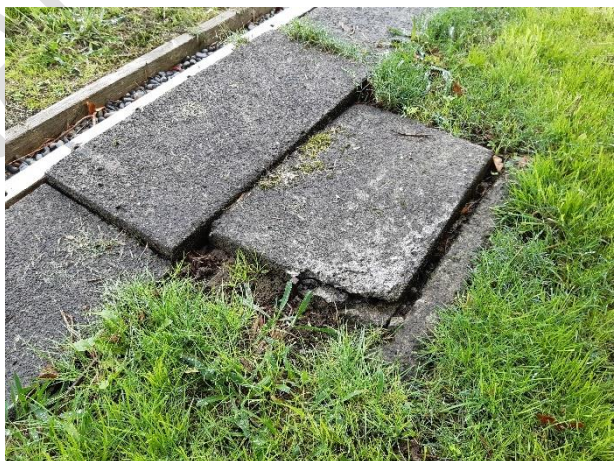
31	Uneven pavers to be made good.

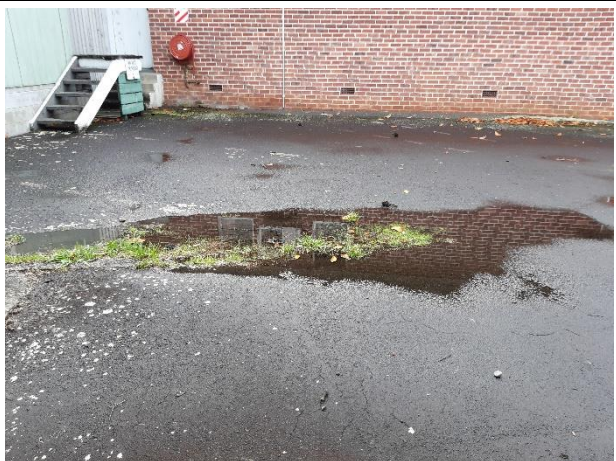
32	Uneven driveway surface to be remediated.

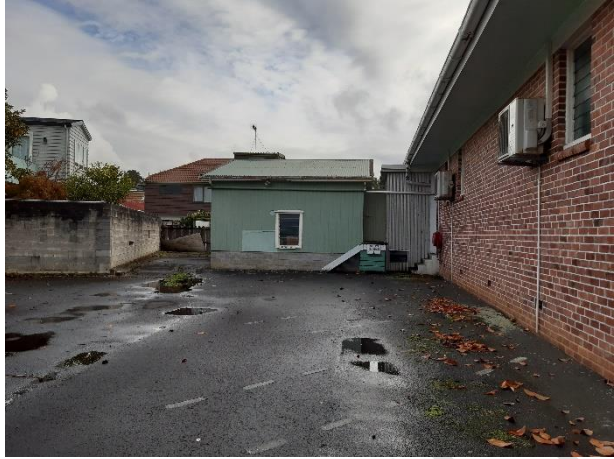
2	<p>Uneven asphalt driveway to be made good.</p>

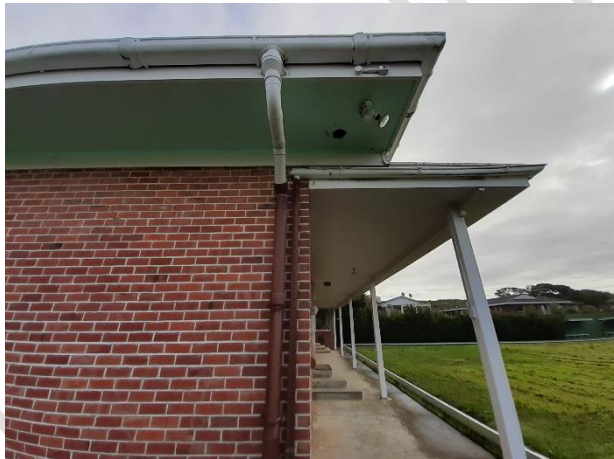
3	<p>Spouting and gutter systems to be checked during heavy and prolonged rainfall.</p>

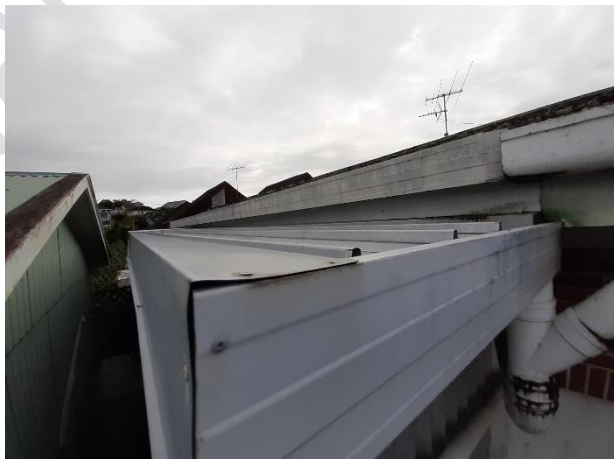
4	<p>Flat roof at rear of Main Pavilion.</p>

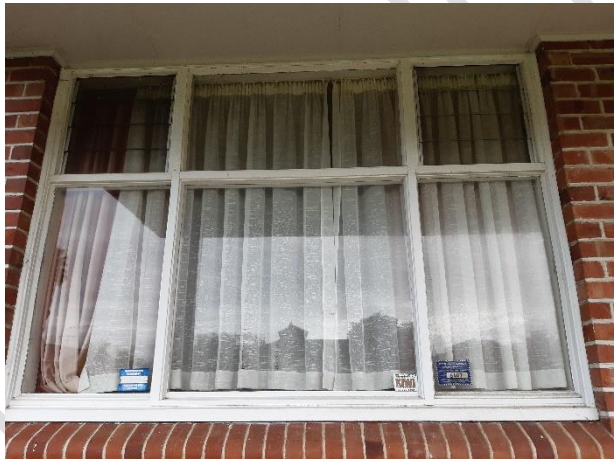
7	Paint and ease and adjust all windows as required.

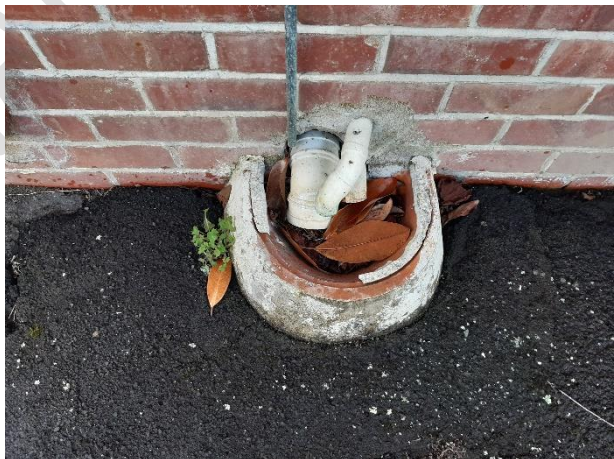
17	Gully trap to comply with standards. Cover required.

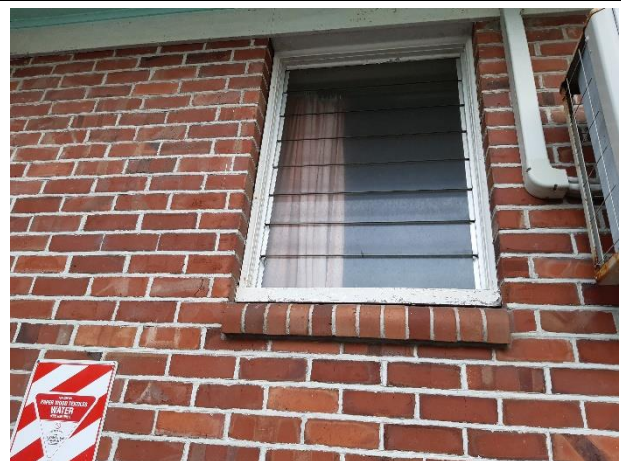
22	General window cleaning required.

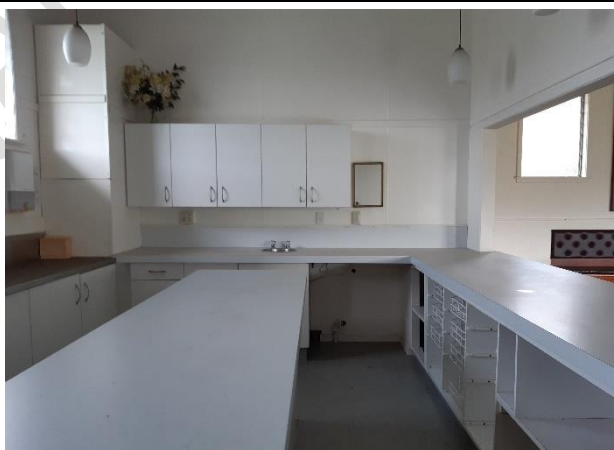
33	Kitchen cabinet in fair condition.

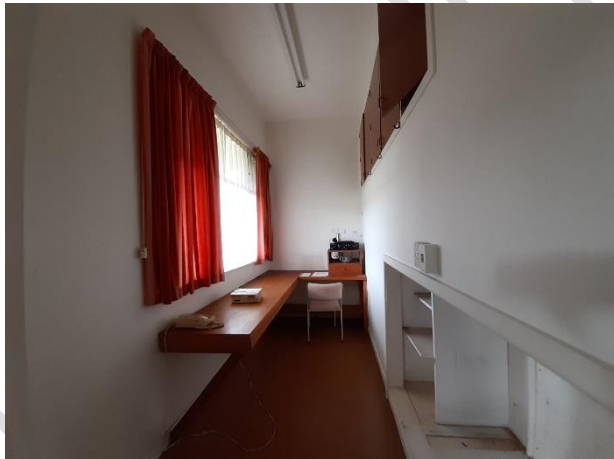
40	Office wall cabinets to be removed if not in use.

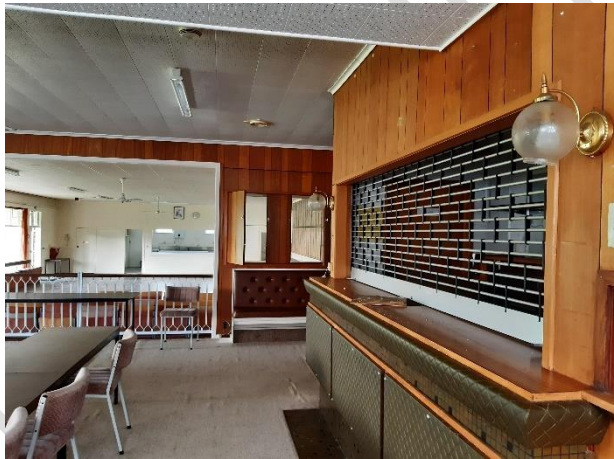
48	Bar counter and fridge.

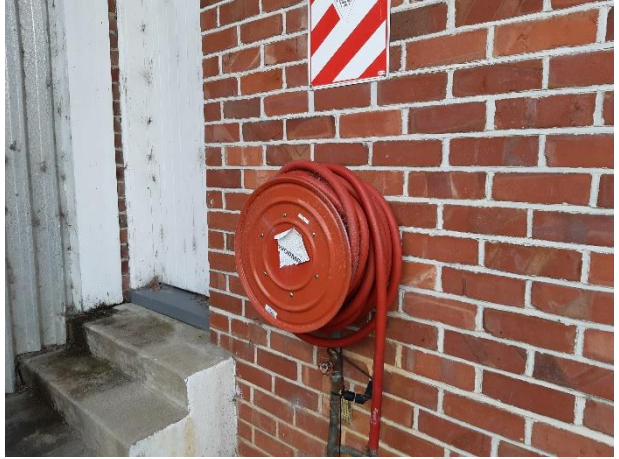
55	Fire hose reel – service and check required.

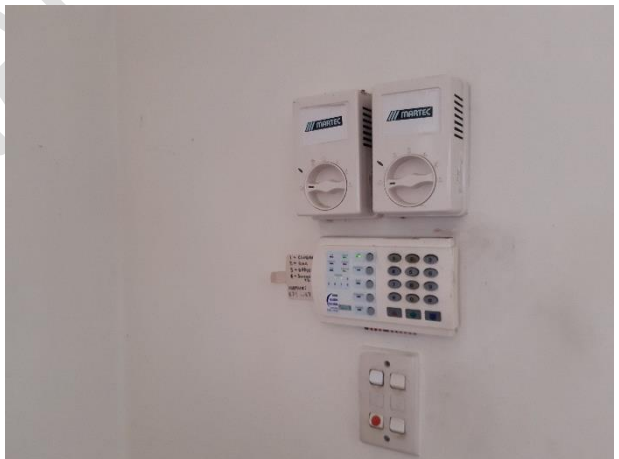
57	BWOFF has not been renewed.

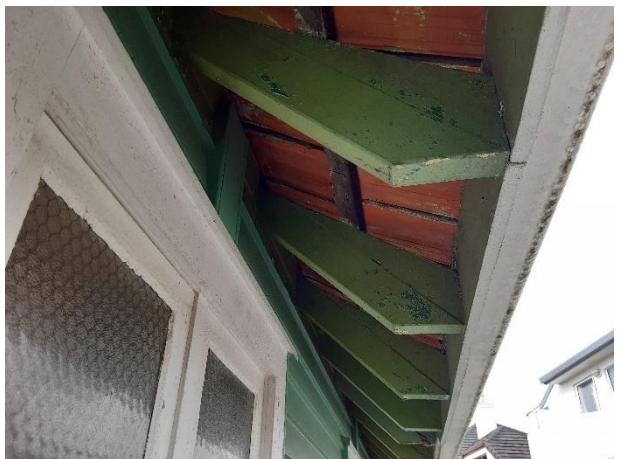
13	Make good and repaint weatherboard.	 
14	General cleaning recommended for all windows.	 
15	General cleaning recommended for all windows.	 
16	General cleaning recommended for all windows.

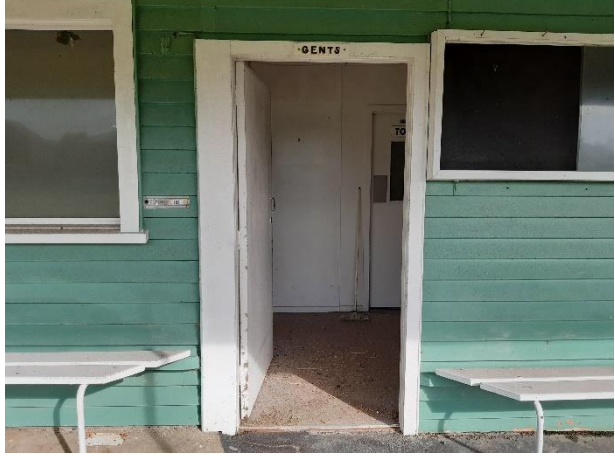
21	Male Locker room. Ceiling appears to be mould affected with condensation - to be cleaned. Suggest to install an extractor fan and improve heating, ventilation and insulation.

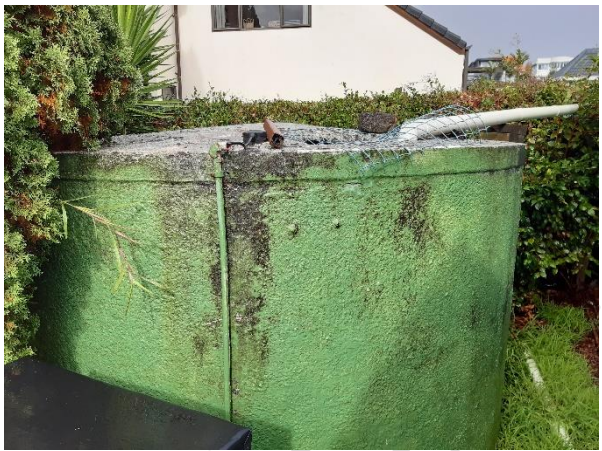
2	Cleaning and maintenance of the water tank recommended.

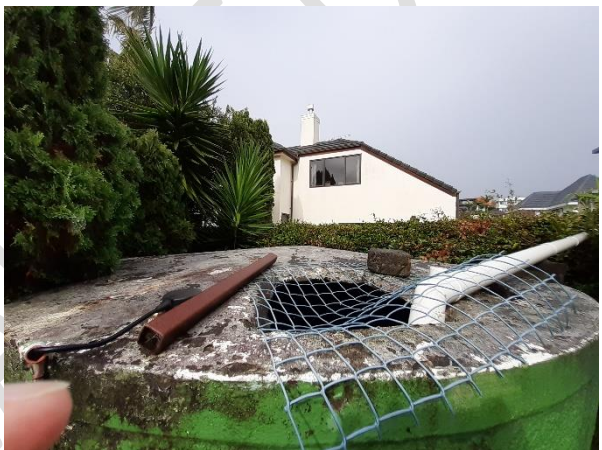
3	Cleaning and maintenance of the water tank recommended.

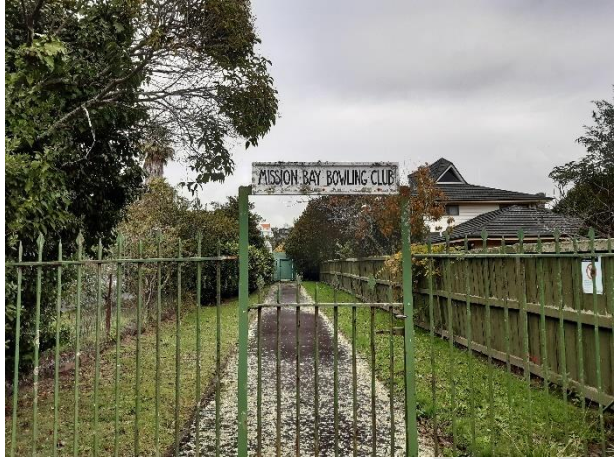
2	<p>Nihill Crescent entrance.</p> <p>Suggest to dismantle the fence/gate (proposed use to be confirmed) instead of incurring maintenance costs.</p>

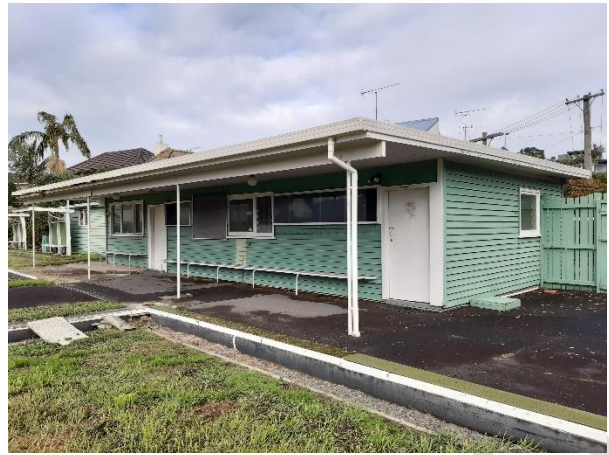
6 View of Toilet and Locker Room Block

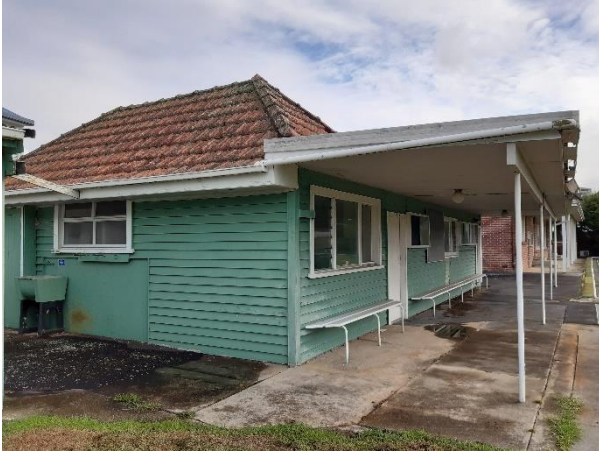
7 View of Toilet & Locker Room Block

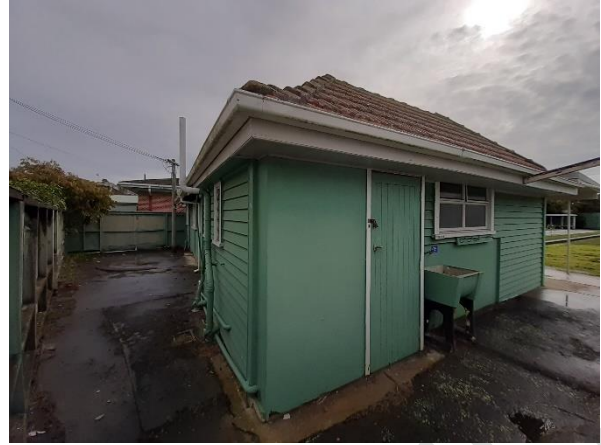
8 Rear of the Toilet and Locker Room Block

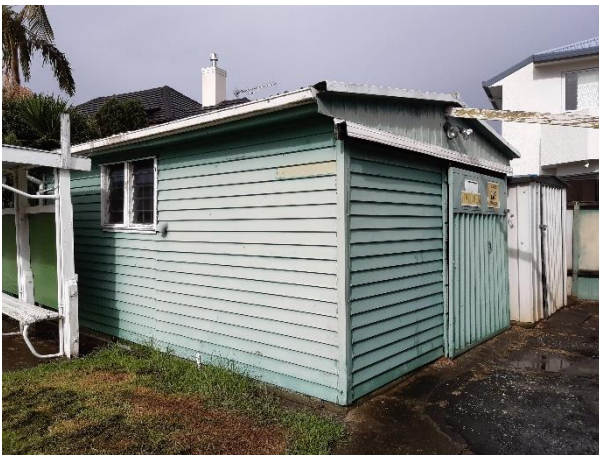
9 Hazchem and Storage Shed

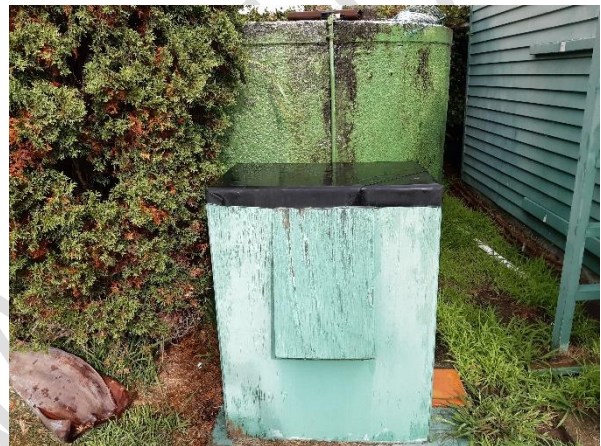
10 Concrete water tank

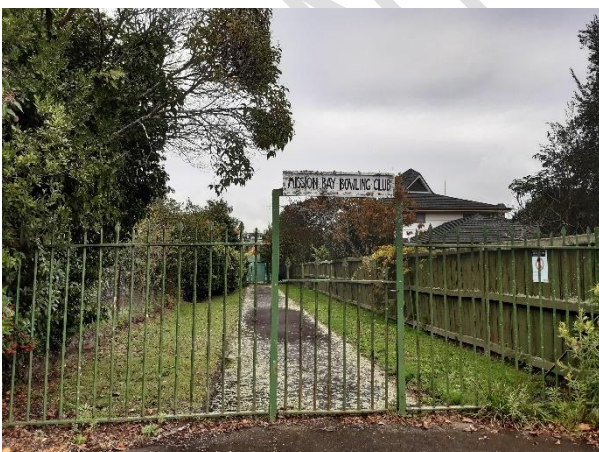
11 Entrance from Tagalad Road

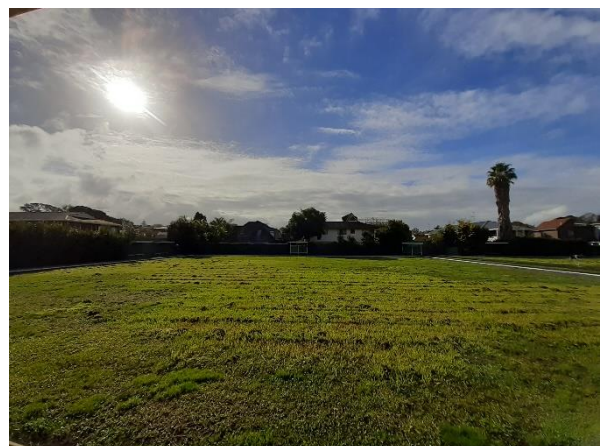
12 Bowling Green

5	Remediate any loose timber fasteners for the bowling green.
